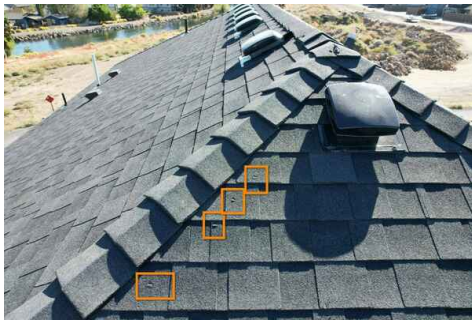
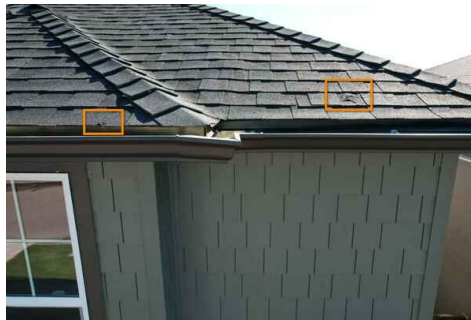
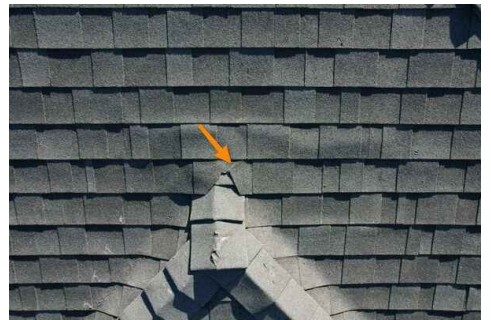
#### CRACKED AND DAMAGED ROOF COVERING

I observed a few areas of damaged roof covering materials. Recommend inquiring with builder about repairs.

Recommendation  
Contact your builder.

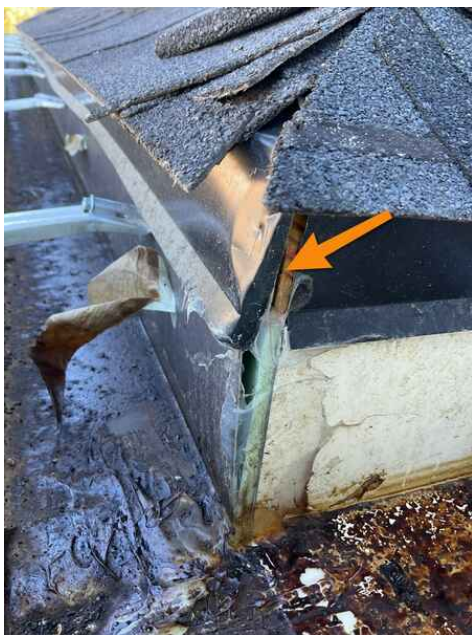
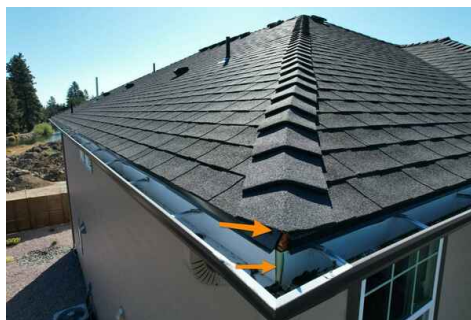
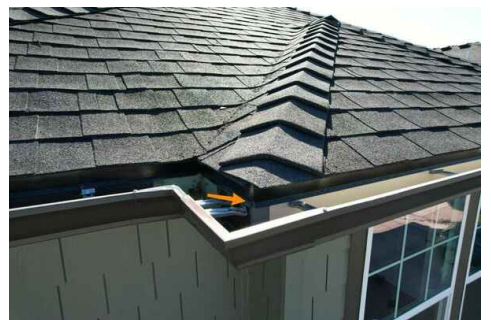
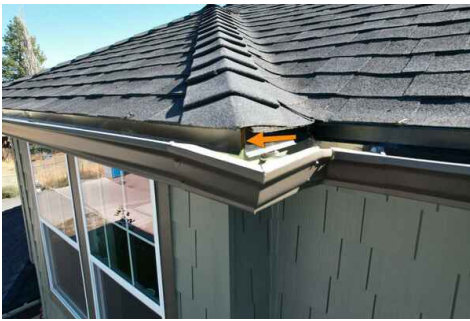
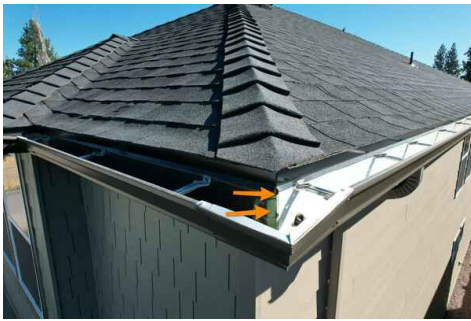
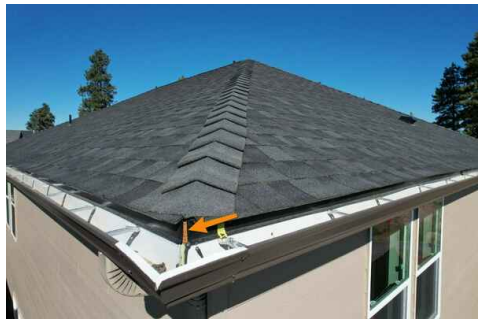
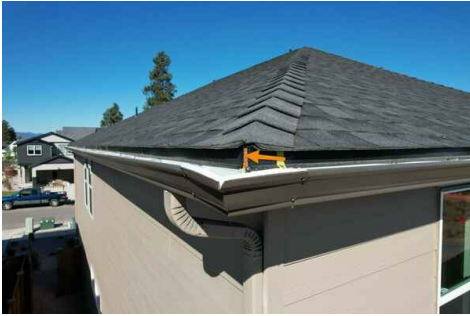
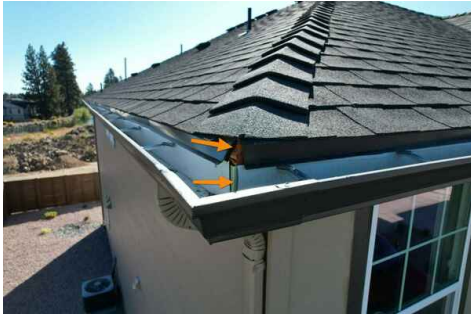
Front

#### DRIP EDGE FLASHING GAPS

Drip edge flashing not installed to best practices. Exposing bare wood which can lead to moisture issues on roof decking. Recommend repair to prevent water damage.

Recommendation  
Contact your builder.

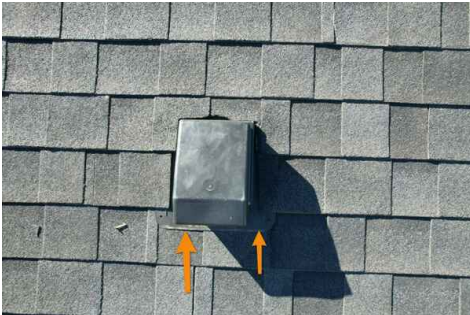
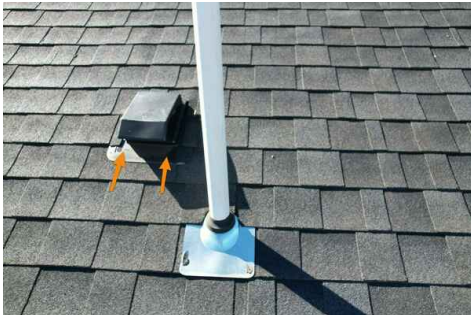
### VENTILATION PENETRATIONS NOT SECURED

It appears these ventilation penetrations were not secured with fasteners. They could be loose and cause damage when storms/wind events happen. Recommend builder verify for proper installation.

Contact your builder.

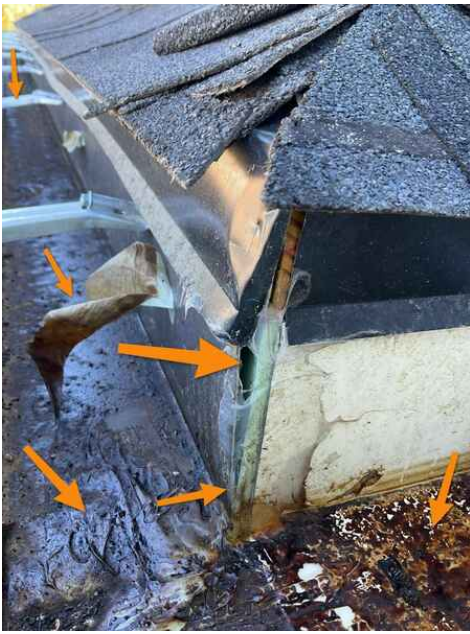
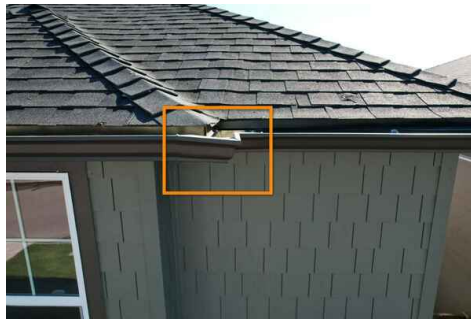
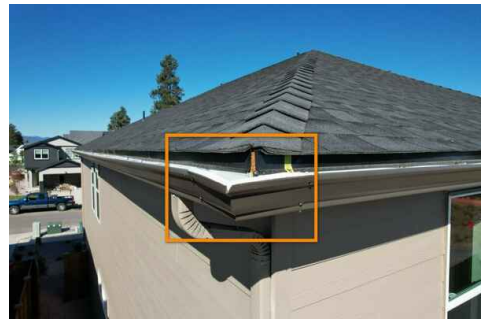
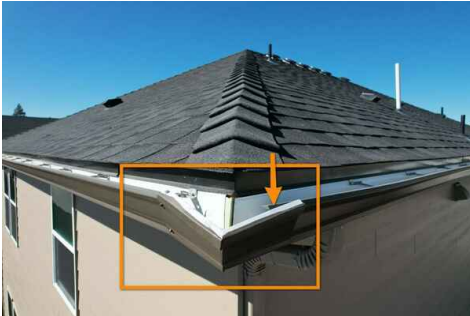
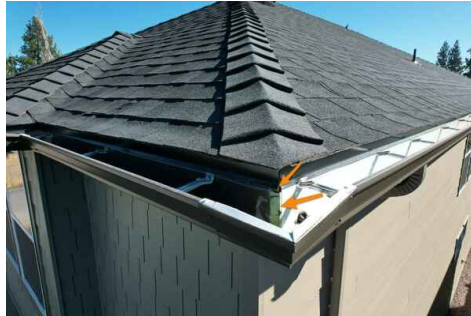
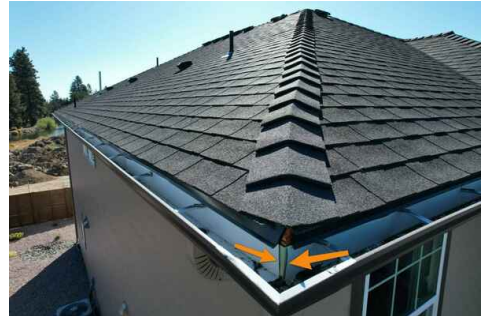
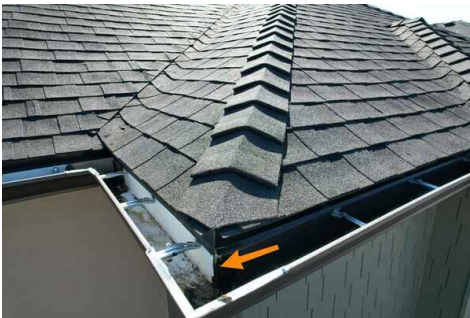
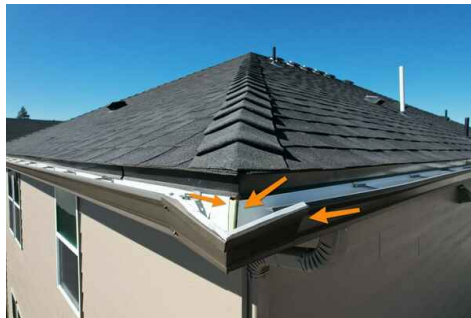
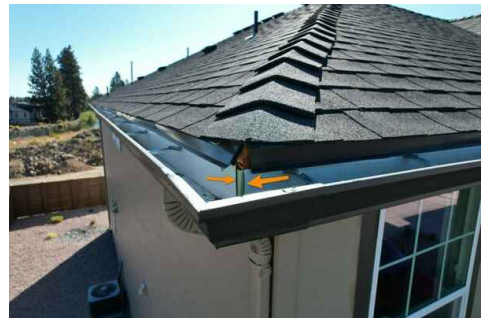
### GUTTER IMPROPER INSTALLATION

Gutter transitions were bent and sloped, which may effect water drainage from gutters, gaps in gutter transitions with no sealant or overlap which will cause leaks and not divert water appropriately. Black substance running length lower gutter in front. Recommend evaluation of gutter system and repairing areas for proper function of gutters.

Contact your builder.

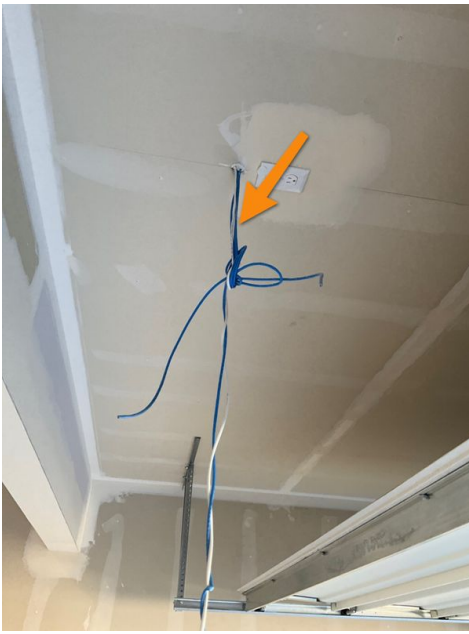
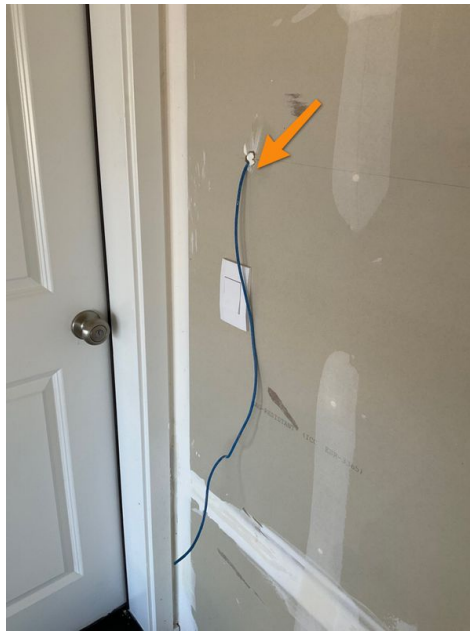
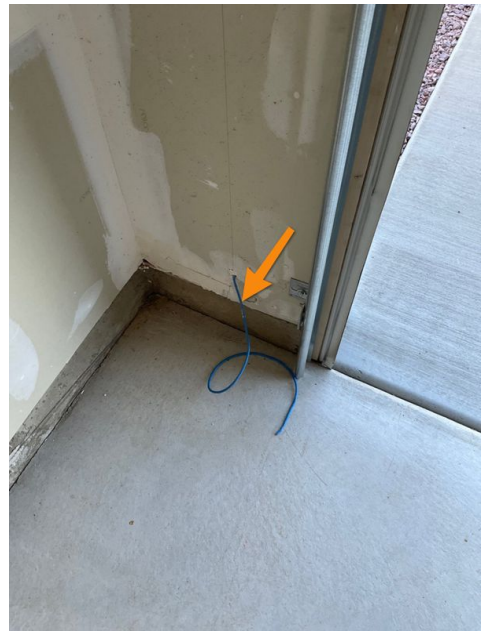
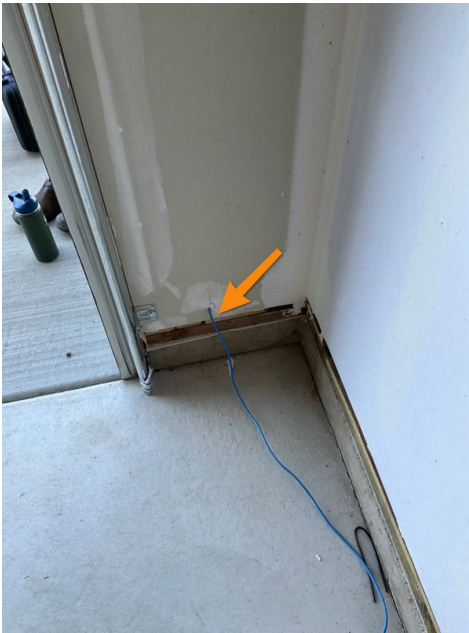
#### 5.4.1 Garage Vehicle Door Opener **OPENER NOT PRESENT**

Wired for automatic garage door opener. Consult with builder if it was supposed to be installed.

Recommendation  
Contact your builder.

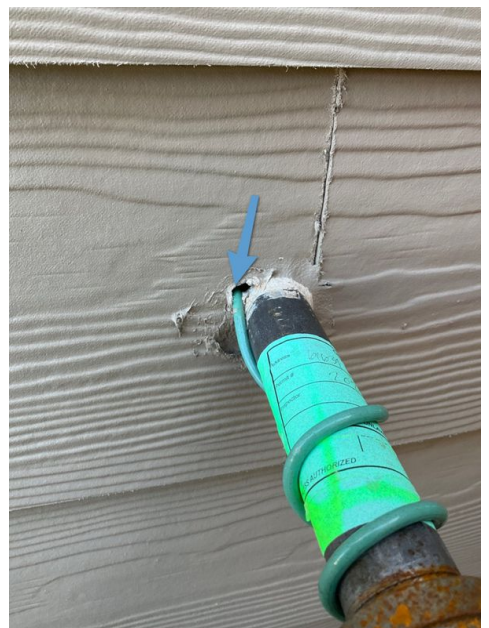
Right Side Gas Line

### HOLES IN SIDING

Holes In Siding. Recommend caulking and painting to prevent water intrusion.

Recommendation  
Contact your builder.

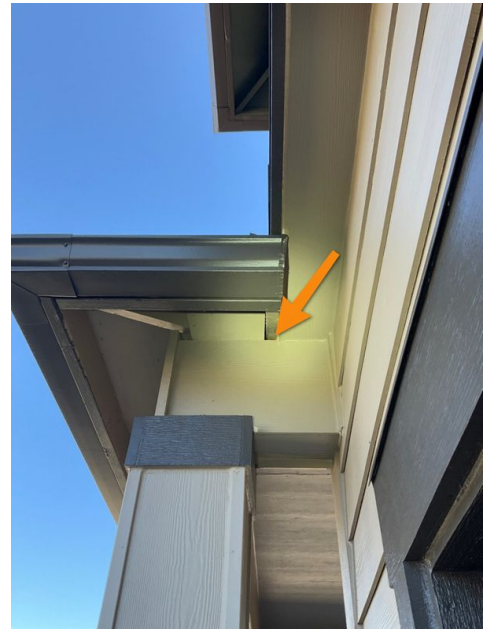
Front Left Garage

#### MISSING TRIM

I observed missing trim in this area. Recommend installing trim to keep out rodents and the elements.

Contact your builder.

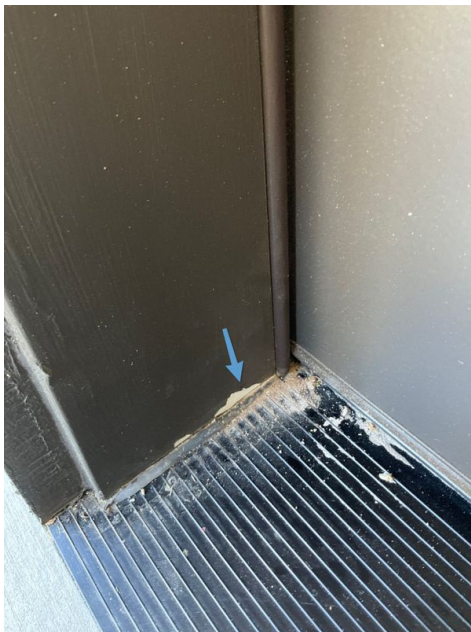
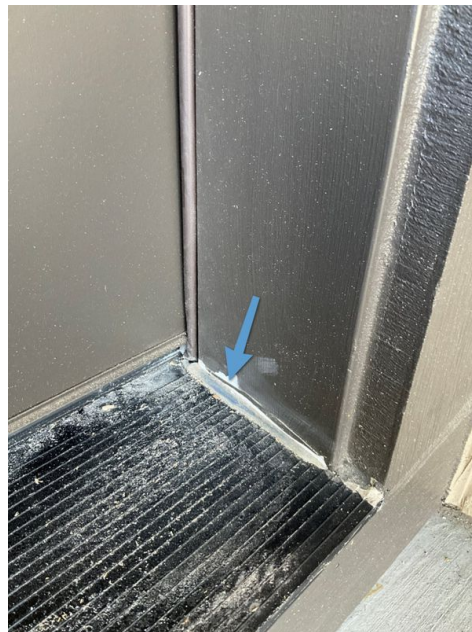
Front Door

#### PAINT MAINTENANCE

A little paint could be touched up on front door.

Contact your builder.

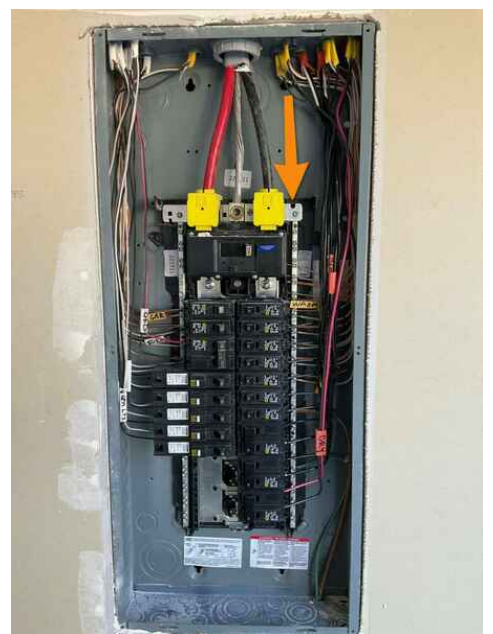
#### GREEN BONDING SCREW MISSING

Appears green bonding screw was not installed in service panel. The green screw is used to bond (fasten) the neutral to the metal box. This is only done in the main panel. Recommend builder evaluate and remedy as necessary.

Recommendation  
Contact your builder.

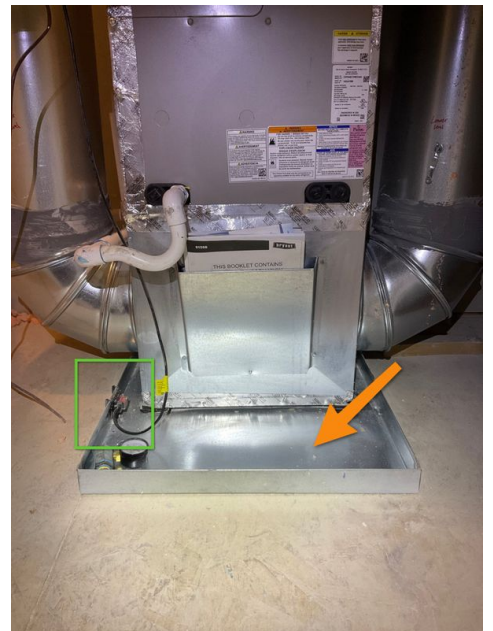
### DRAIN PAN OVERFLOW MISSING

The drain pan had no overflow. To reduce the potential for damage from a leaking tank or pipe fittings, the drip pan should have an overflow pipe installed that discharges to the home exterior or to a floor drain. Green box shows installed float valve which should shut equipment off if pan fills with water. Recommend correction by a qualified plumbing contractor.

Recommendation  
Contact your builder.

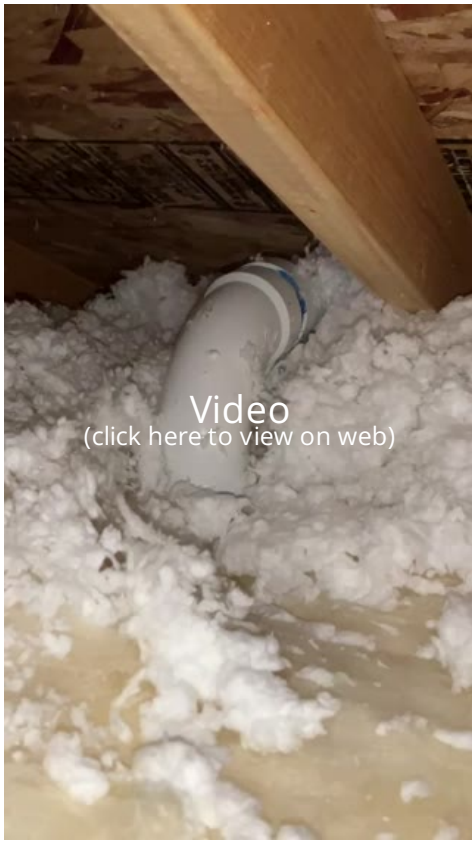
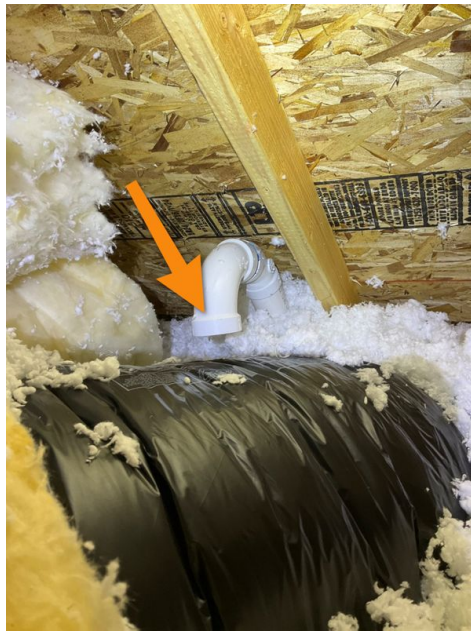
Moved Insulation A Bit

### FRESH AIR INTAKE BLOCKED

See video. This can cause carbon monoxide issues and inefficient furnace operation. I moved some insulation away from intake, but recommend HVAC specialist repair and put insulation back where it was.

Recommendation  
Contact your builder.

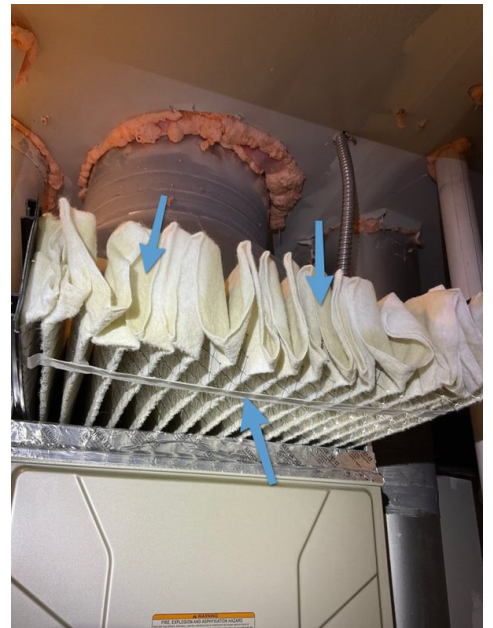
##### **FILTER DIRTY**

The filter was a little dirty. It is recommended that filters are changed ever/cleaned 30 days or when dirty.

Recommendation  
Contact your builder.

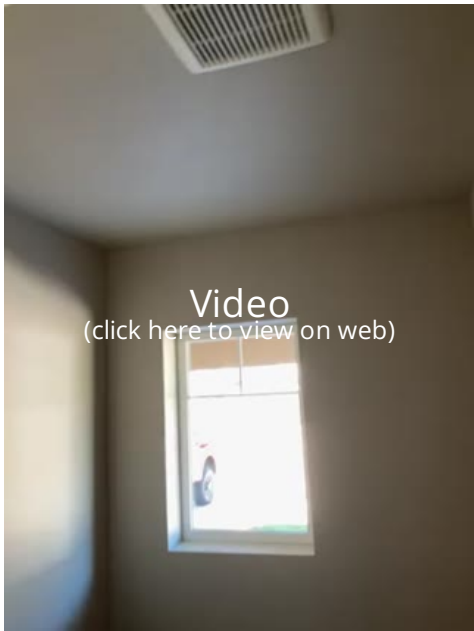
#### 9.5.1 Temperature Readings **NUMBER OF VENTS**

Informational only as there was no vent in the middle room on first floor. Ask builder if that was by design and if vents in the rest of first floor will be sufficient.

Recommendation  
Contact your builder.

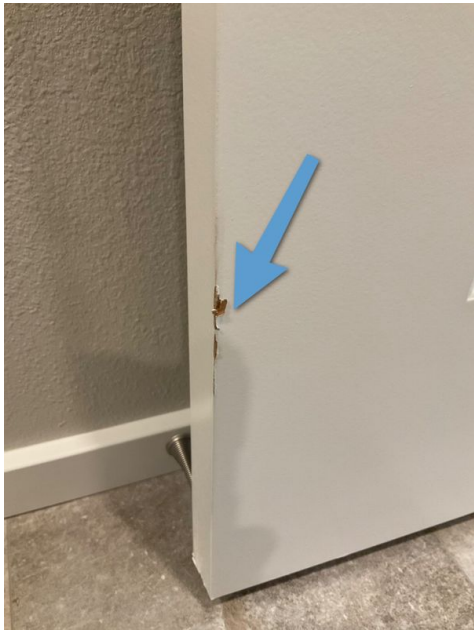
2nd Floor Guest Bathroom

**DAMAGED DOOR**

I observed damage to the door. Repair as necessary.

Recommendation  
Contact your builder.

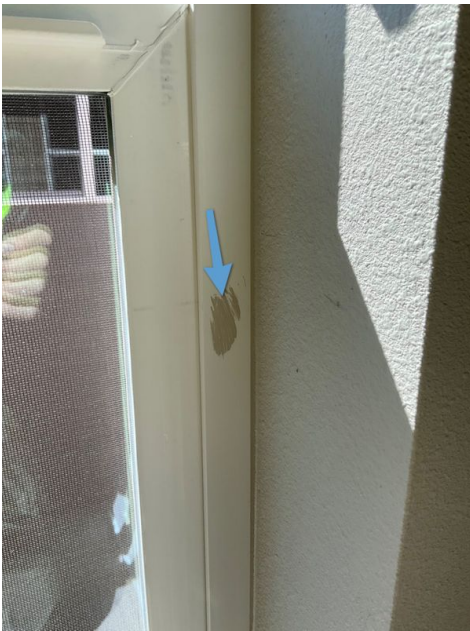
**PAINT MARKING**

Some paint from walls was on window side jamb, recommend removing as necessary.

Recommendation  
Contact your builder.

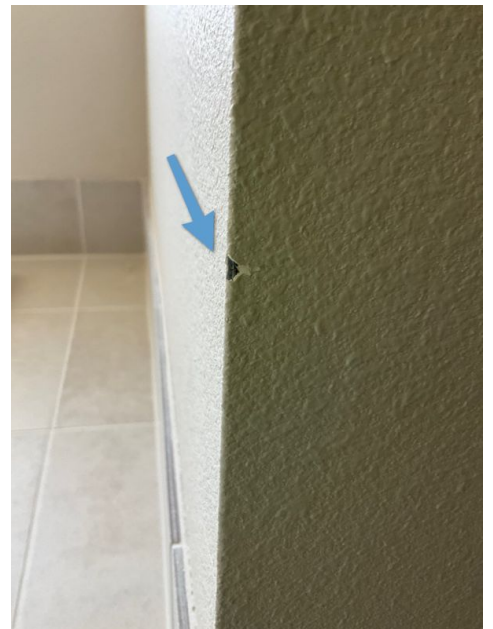
Primary Bathroom Between Shower Tub

### WALL DAMAGE

I observed damage at the bathroom wall, between shower and tub in primary bathroom. Repair as necessary.

Contact your builder.

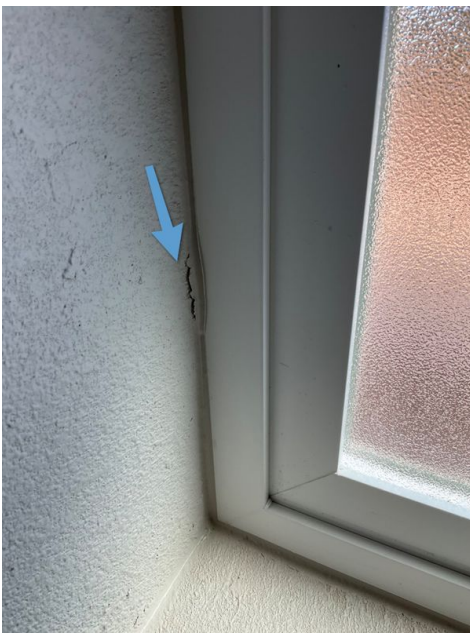
Primary Bathroom Tub Window

### CAULK MAINTENANCE

Caulk was pulling away from window area by tub window in primary bathroom. Recommend re-caulking area as necessary.

Contact your builder.

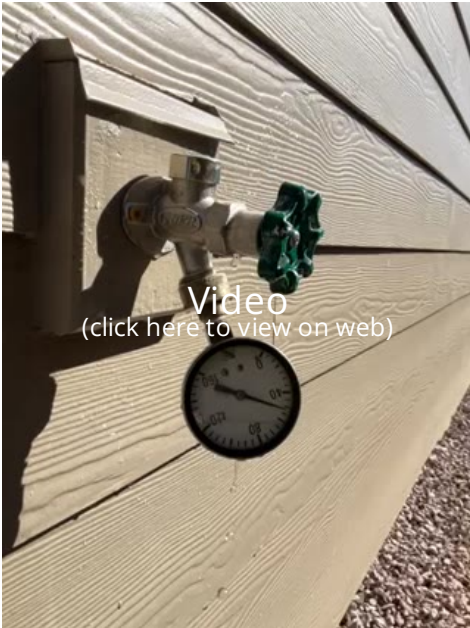
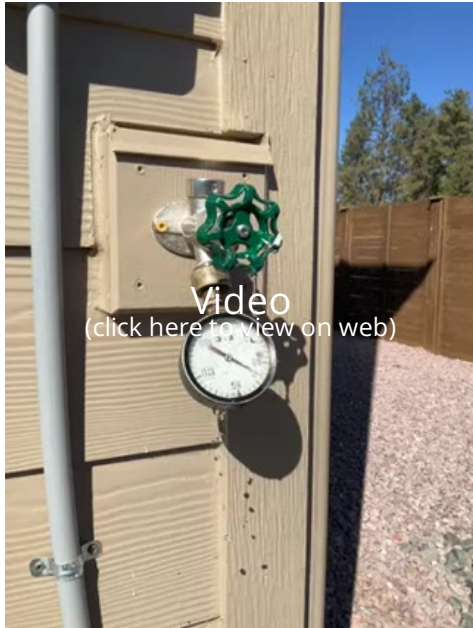
14.3.1 Water Supply & Distribution Systems  
**LEAKING SPIGOT**

Recommendation  
Contact a qualified plumbing contractor.

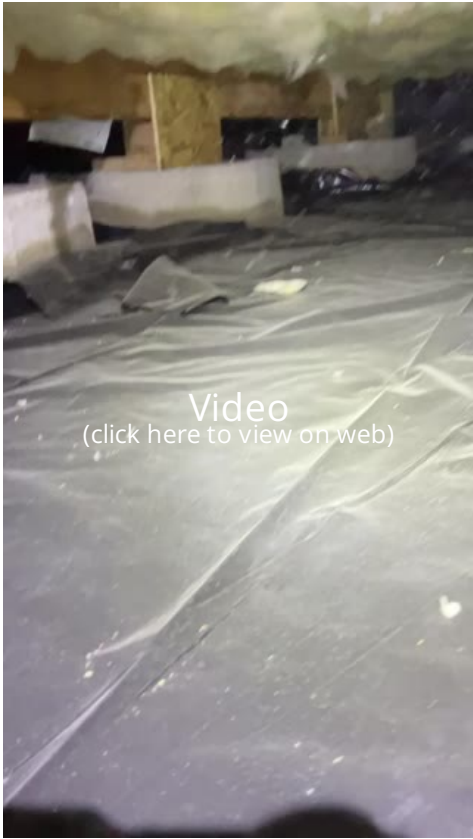
15.1.1 Foundation & Under Floor Crawlspace  
**STANDING WATER**

See videos. I could not get 5' past the hatch due to standing water. I was unable to inspect the crawlspace. Recommended finding source, repairing and removing standing water from crawlspace and drying out crawlspace to prevent moisture issues.

Recommendation  
Contact your builder.
