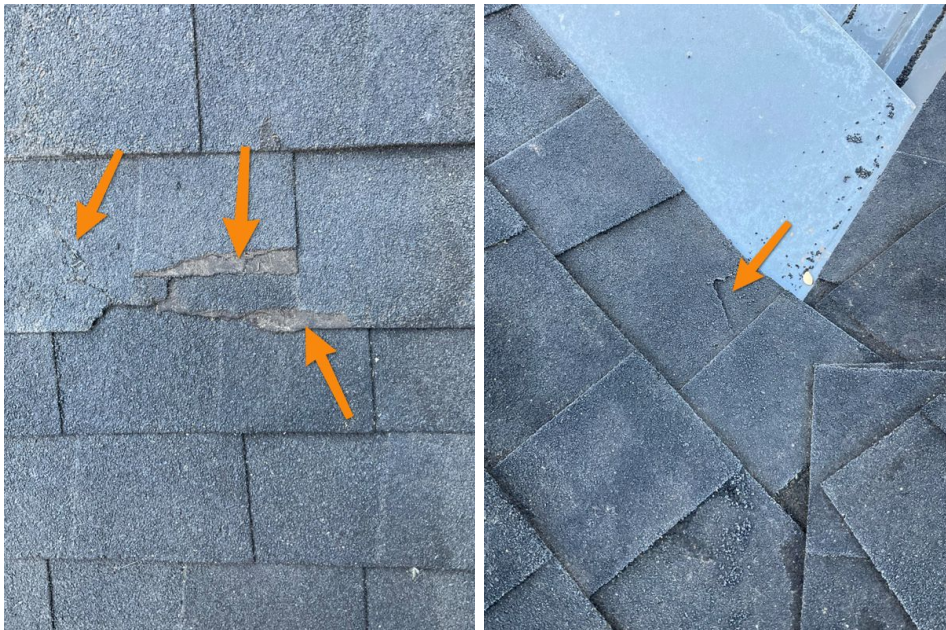
3.2.1 Roof Covering

CRACKED AND DAMAGED ROOF COVERING

I observed areas of cracked/splitting and damaged roof covering materials. Prone to leaking. Correction and further evaluation by a professional roofer is recommended.

Recommendation
Contact your builder.

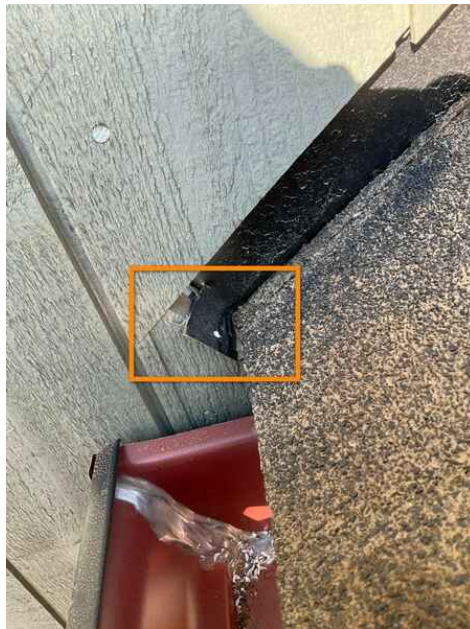
KICKOUT FLASHING - INADEQUATE

Kickout flashing did not appear adequate. Some flashing areas could allow water to get behind siding or not direct water properly into gutter. Recommend a roofing professional further evaluate and make necessary corrections.

Recommendation
Contact your builder.

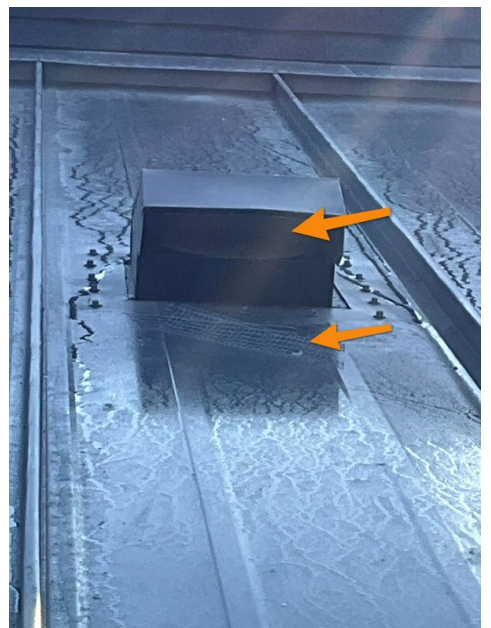
3.4.1 Roof Penetrations

VENT SCREEN

Vent screen in rear of house fell off. Recommend securing screen to prevent rodent/insects from entering.

Recommendation
Contact your builder.

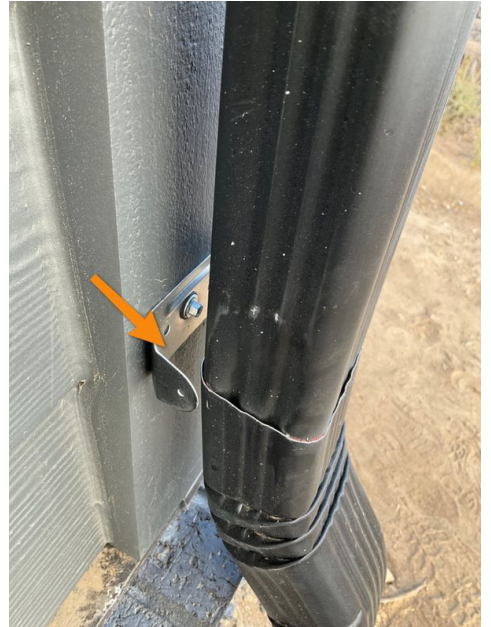
3.5.1 Gutters & Downspouts

GUTTER FASTENING DEFECT

I observed indications of a defect at the gutter fastening. This may cause the gutters to sag and not drain water properly. Recommend repairing as necessary.

Contact a qualified gutter contractor

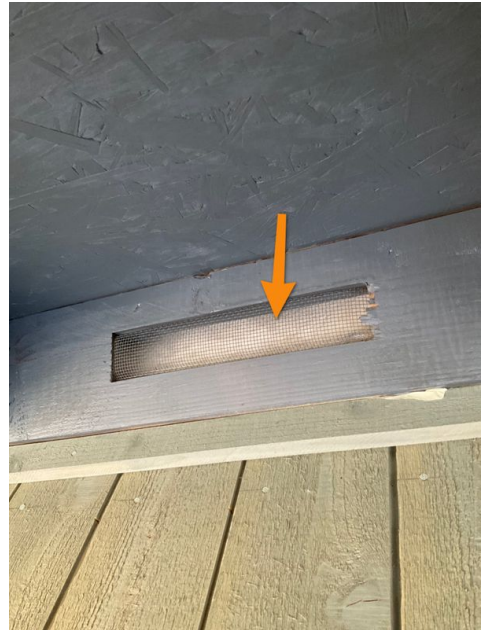
4.3.1 Ventilation In Attic

BLOCKED SOFFIT VENTS

One blocked soffit vent with insulation. Recommend removing insulation from area for proper air flow.

Contact your builder.

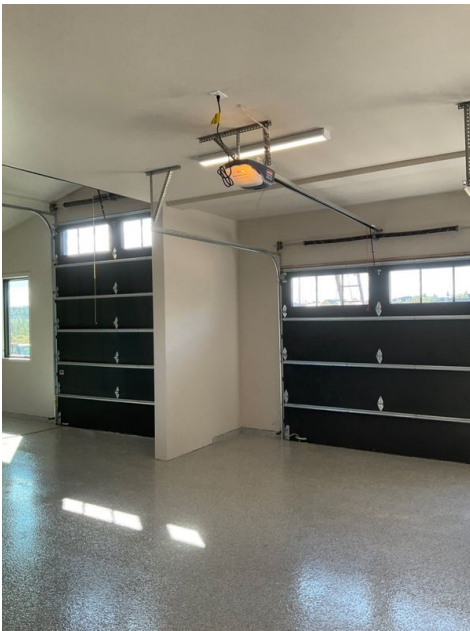
5.4.1 Garage Vehicle Door Opener

NOT OPERATIONAL

General contractor informed me both doors were not operational. Possibly due to when they epoxied garage floor. He stated door company was coming out tomorrow Thursday the 21st recommend verifying repair.

Contact your builder.

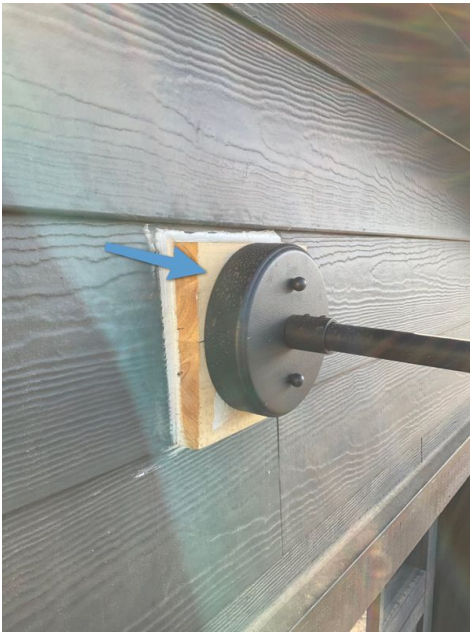
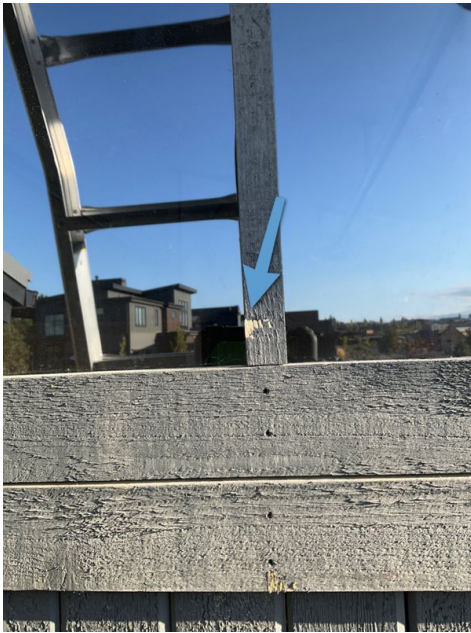
7.3.1 Wall Covering, Flashing & Trim
PAINT MAINTENANCE

I observed indications of paint missing. Recommend painting to protect the wood.
Recommendation
Contact your builder.

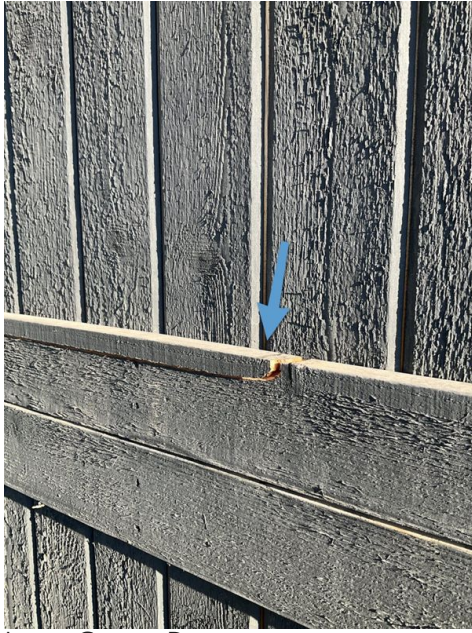
DAMAGED TRIM

Trim was damaged in areas. Recommend fixing damage areas.

Recommendation
Contact your builder.

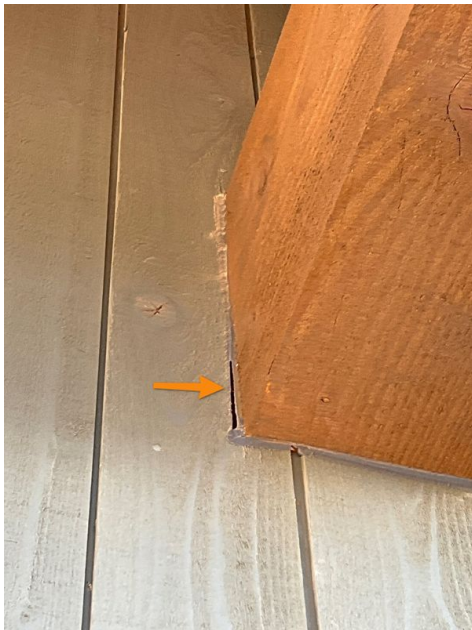
CAULKING MAINTENANCE

I observed areas of caulking in need of maintenance. Recommend ensuring caulk is applied to all areas to prevent water intrusion.

Recommendation
Contact your builder.

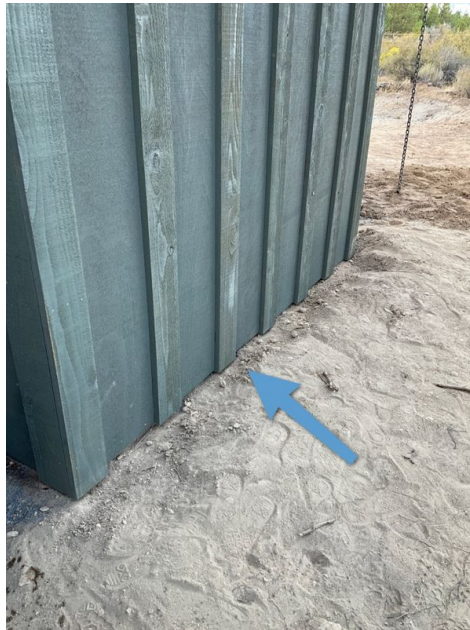
Rear

Siding should generally be 6-8" from ground to prevent water and insect damage, making sure it slopes away from the structure. Recommend correction.

Contact your builder.

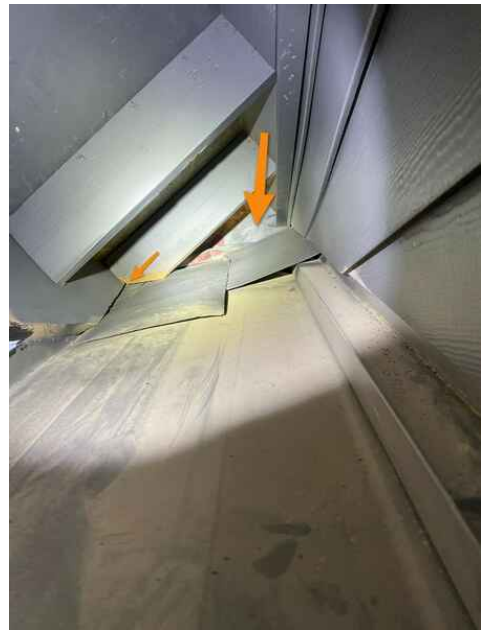
7.3.5 Wall Covering, Flashing & Trim

MISSING TRIM/SIDING

I observed missing trim/siding in this area. House wrap was showing. Recommend making sure siding is covering all areas to prevent damage to structural components of house.

Contact your builder.

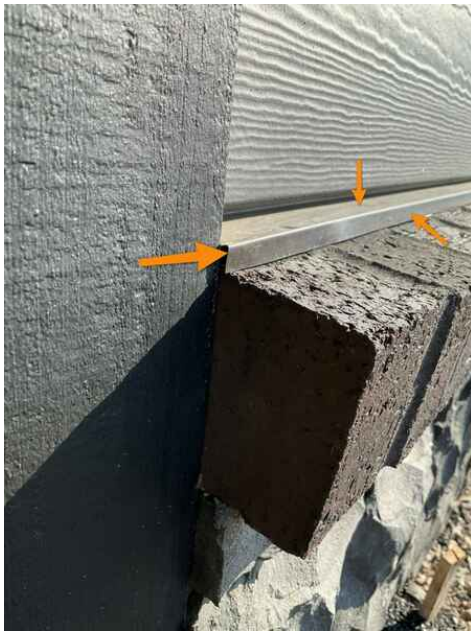
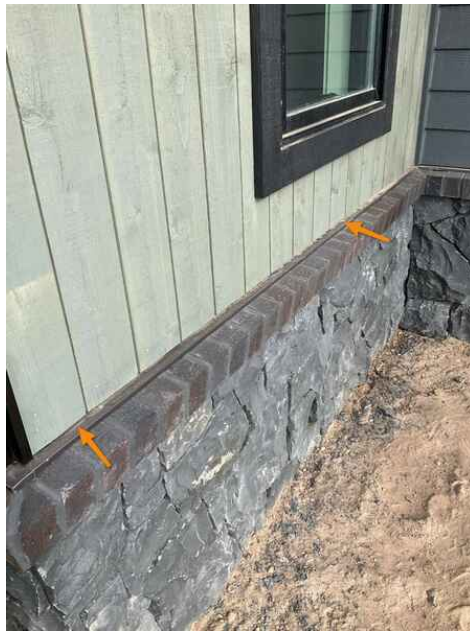
Figure 24
Brick Veneer/Siding Transition

FLASHING MATERIALS

Inquire with builder or siding professional as to proper flashing installed between siding and brick. "Z" flashing will usually go all the way to the edge and over the side of the brick, which makes it aesthetically unpleasing. "L" flashing will terminate earlier to show the top of the brick, but still be properly flashed. This "Z" flashing did not extend past and over brick edge.

Contact your builder.

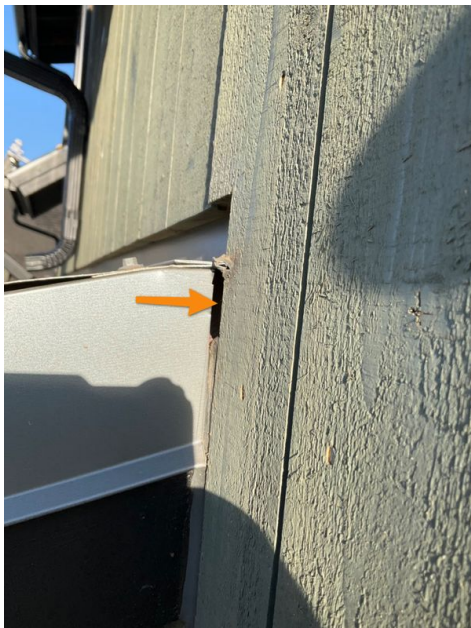
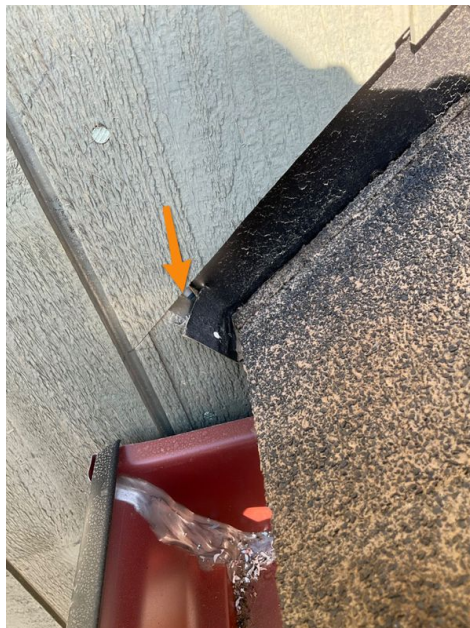
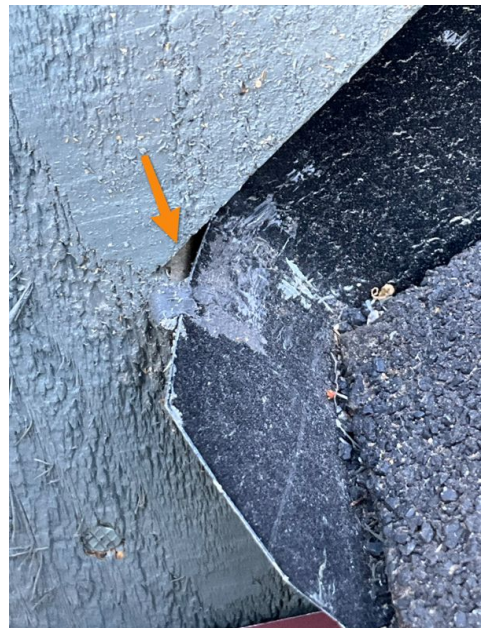
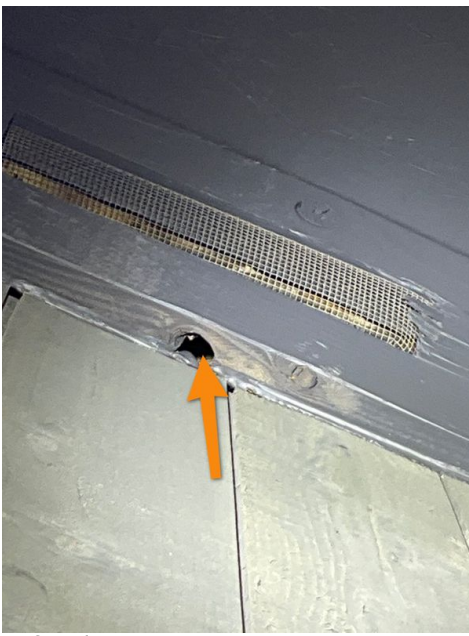
Gaps in siding could allow water or pests to enter. Recommend sealing gaps to prevent issues.

Recommendation
Contact your builder.

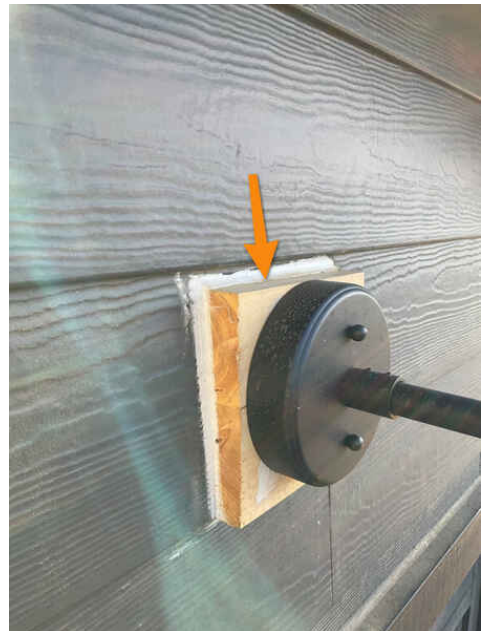
7.3.8 Wall Covering, Flashing & Trim

MISSING FLASHING

Flashing was not on blocking, it was caulked, but should have flashing to prevent water intrusion and direct water away from siding. Recommend repair for proper flashing.

Recommendation
Contact your builder.

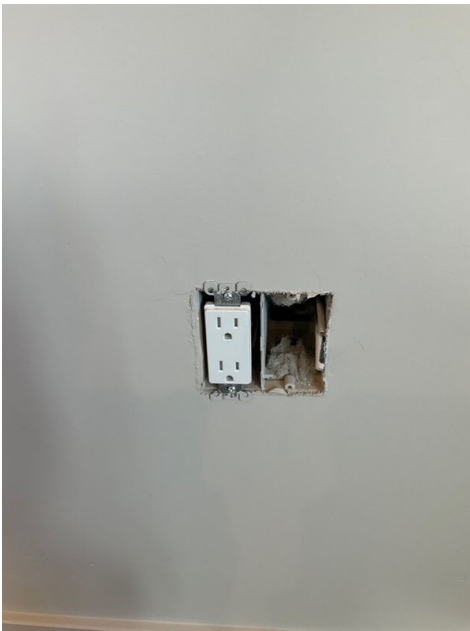
8.1.1 Switches, Fixtures & Receptacles

COVER PLATES MISSING

Receptacle was missing its cover. This could pose a shock hazard, recommend installing cover for safety.

Recommendation
Contact your builder.

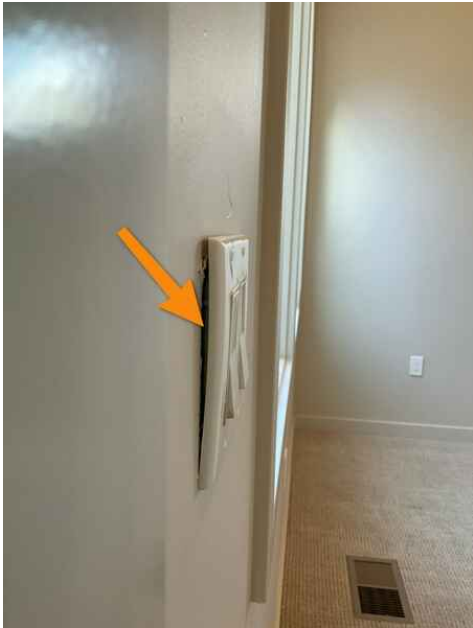
8.1.2 Switches, Fixtures & Receptacles

LOOSE RECEPTACLE

I observed loose receptacles. It could be as easy as tightening the screws behind the plate, or it could be more involved. Recommend starting with tightening screws or replacing the receptacle if necessary.

Recommendation
Contact your builder.

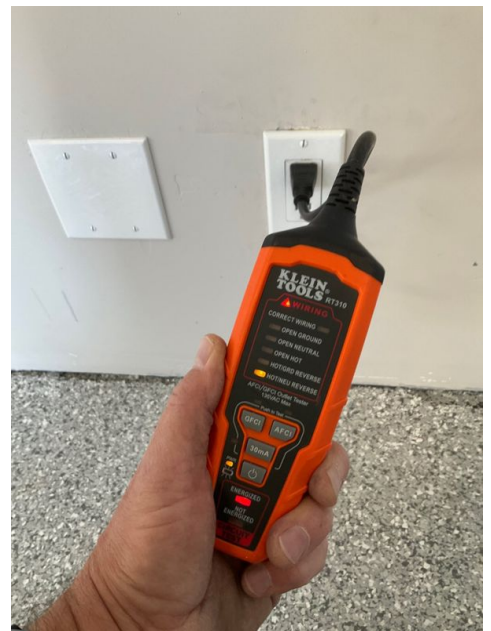
8.1.3 Switches, Fixtures & Receptacles

POLARITY WAS INCORRECT

I observed indications of incorrect polarity at a receptacle.

If your outlet's polarity is reversed, it means that the neutral wire is connected to where the hot wire is supposed to be. This may not sound like a terrible thing, but it is. There is always electricity flowing out of an outlet with reversed polarity, even if an appliance is supposed to be off.

Recommendation
Contact your builder.

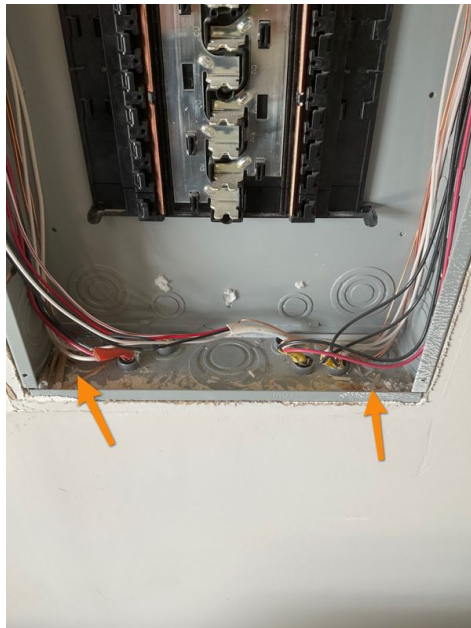
I observed contamination inside the electrical panel. Panel manufacturers do not recommend any materials including debris or overspray inside the panel. Recommend evaluation by qualified electrician.

Recommendation
Contact your builder.

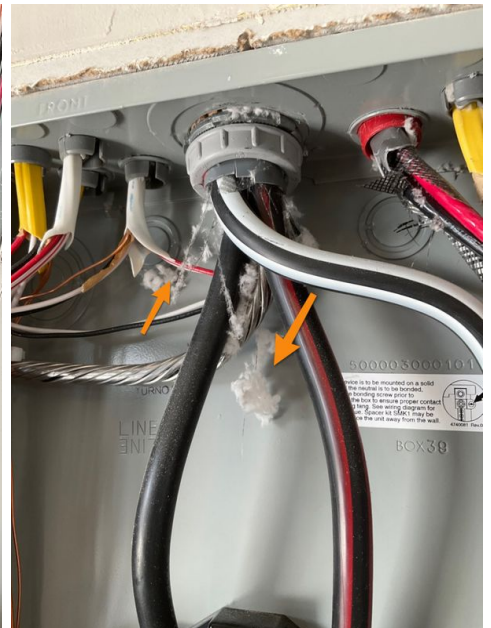
8.7.1 Main Panelboard

CONTAMINATION INSIDE PANEL

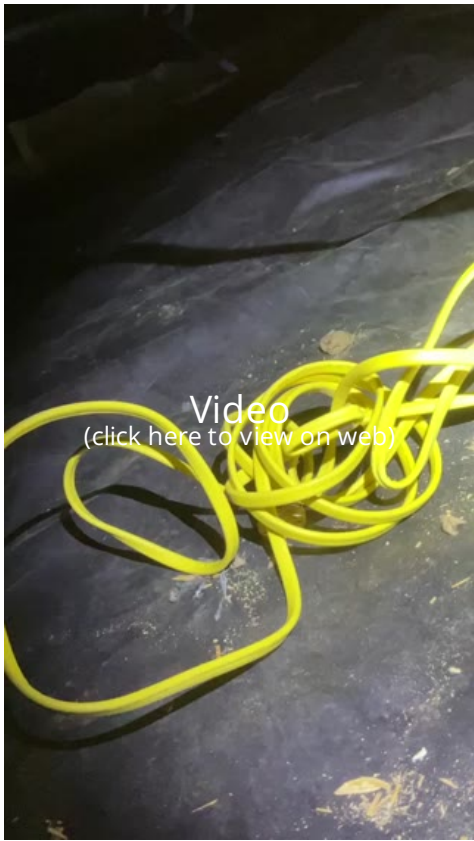
8.10.1 Electrical In Crawlspace

WIRING ON GROUND

Improperly secured live romex which can pose a shock hazard. Recommend securing romex wiring using appropriate methods and terminating properly in junction box.

Recommendation
Contact your builder.

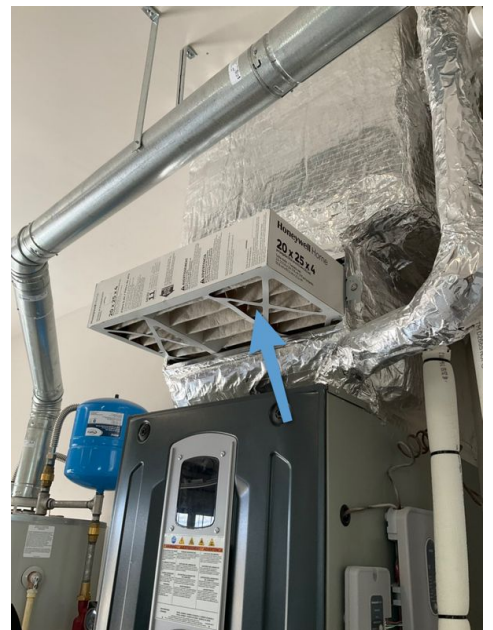
9.4.1 Thermostat, Filter & Normal Operating Controls

FILTER DIRTY

Filter was just a little dirty. I would keep it in there until construction and cleaning is completed and replace upon move in.

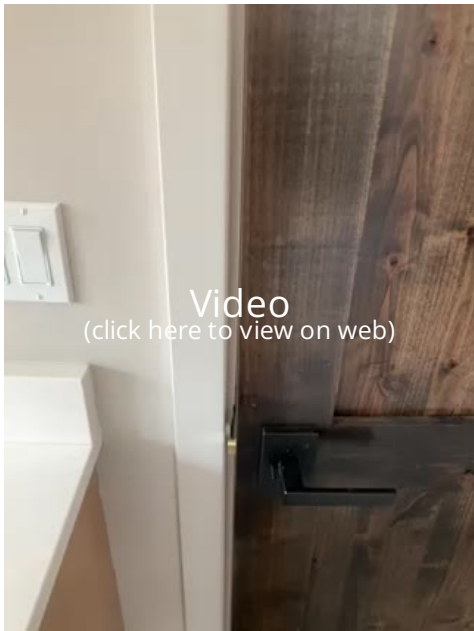
10.1.1 Doors

DOOR DOESN'T LATCH

I observed that a door does not latch and close properly. Repair as necessary for proper operation.

Contact your builder.

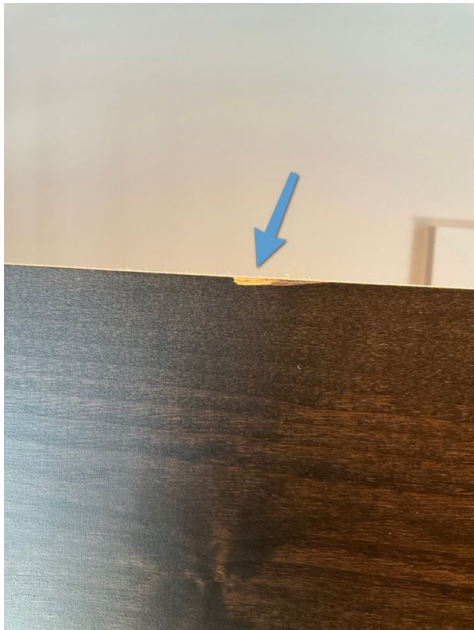
10.1.2 Doors

DAMAGED DOOR

I observed damage to the door. Repair as necessary.

Recommendation
Contact your builder.

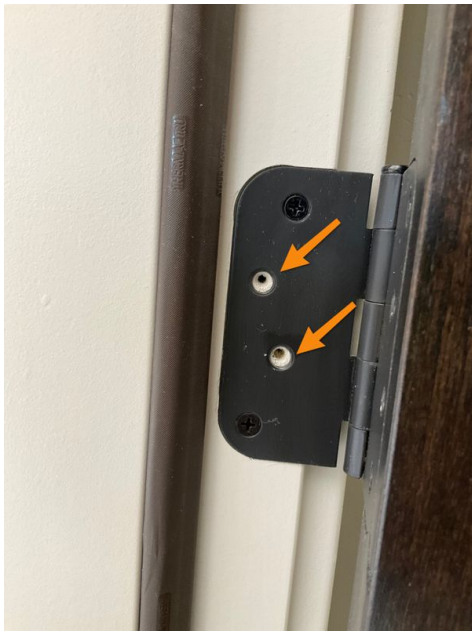
10.1.3 Doors

SCREWS MISSING

Missing screws in door hinges. Recommend installing all screws as designed for hinges for proper operation of door.

Recommendation
Contact your builder.

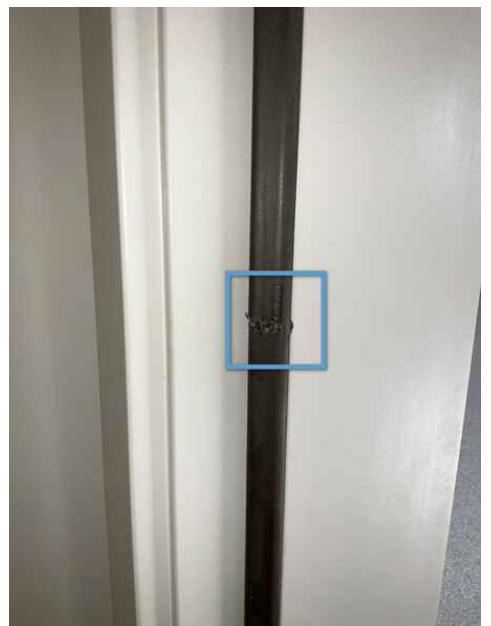
10.1.4 Doors

DAMAGED WEATHERSTRIPING

Weatherstripping was torn in this area. Recommend replacing for proper operation.

Recommendation
Contact your builder.

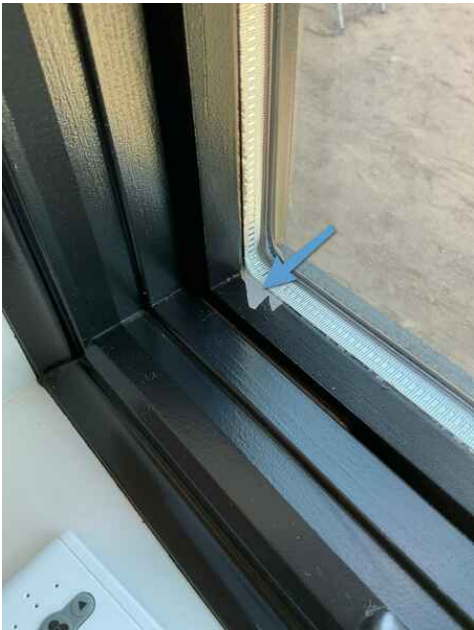
10.2.1 Windows
PAINT PEELING

Paint was peeling in this area. Recommend touch up as necessary.

Recommendation
Contact your builder.

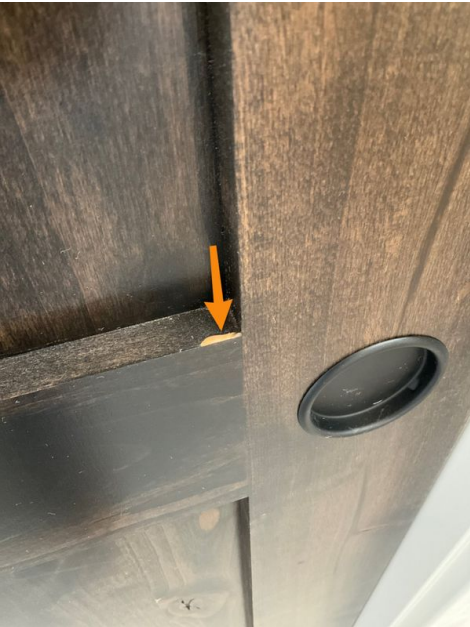
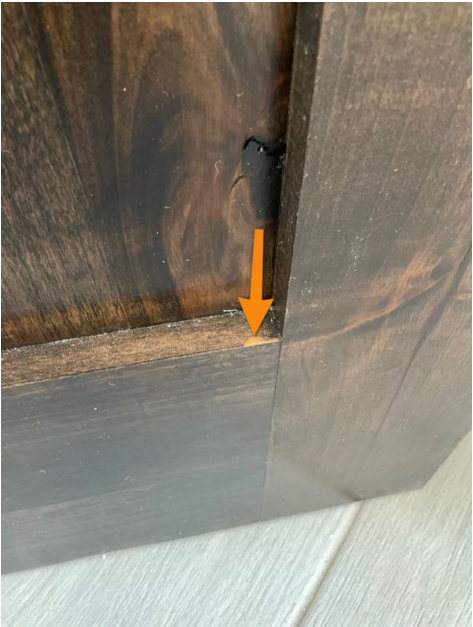
By Garage Door

It looked like chipping, but appeared it was glue left over, recommend removing glue and repair as necessary.

Recommendation
Contact your builder.

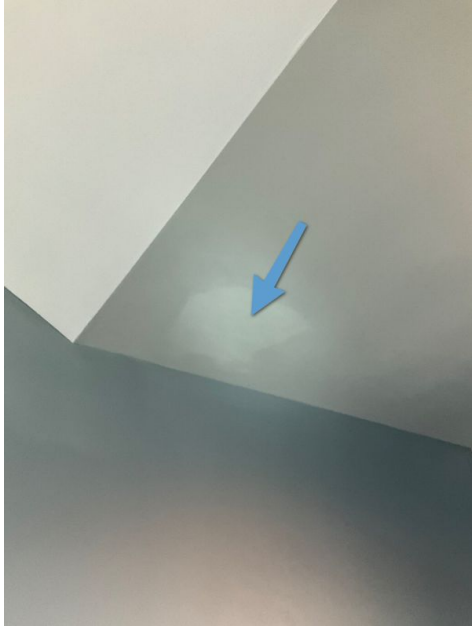
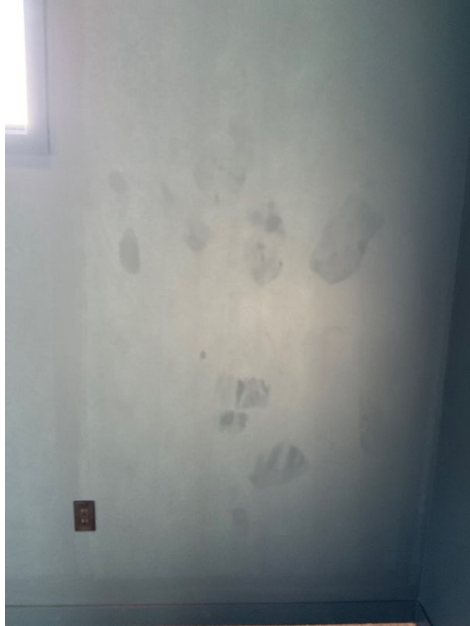
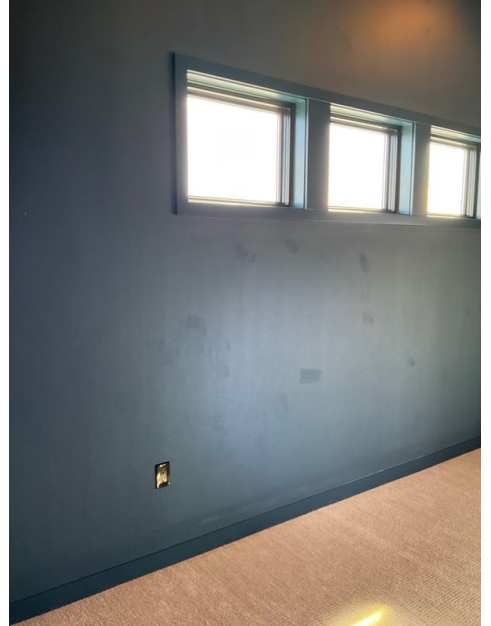
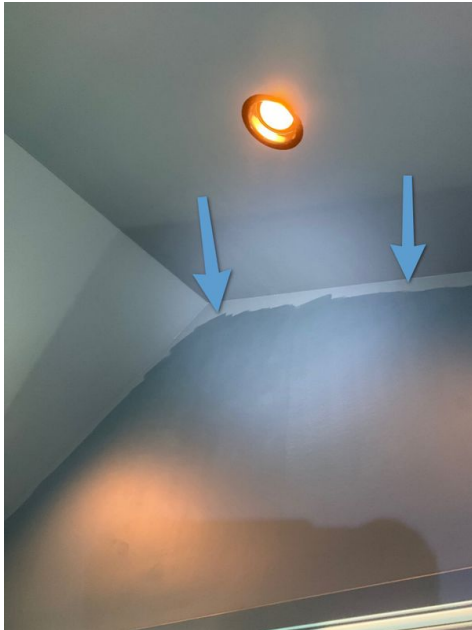
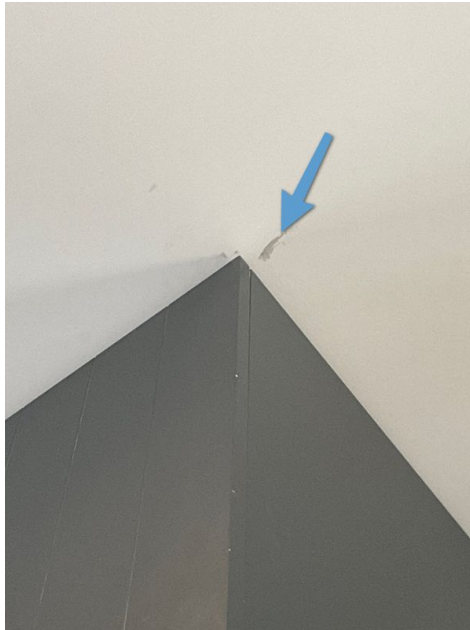
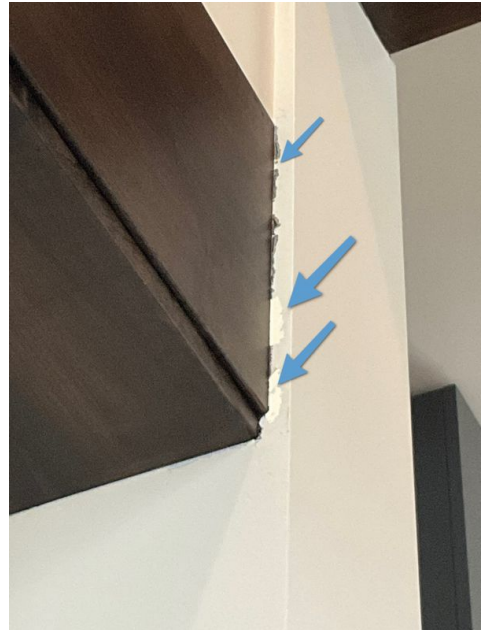
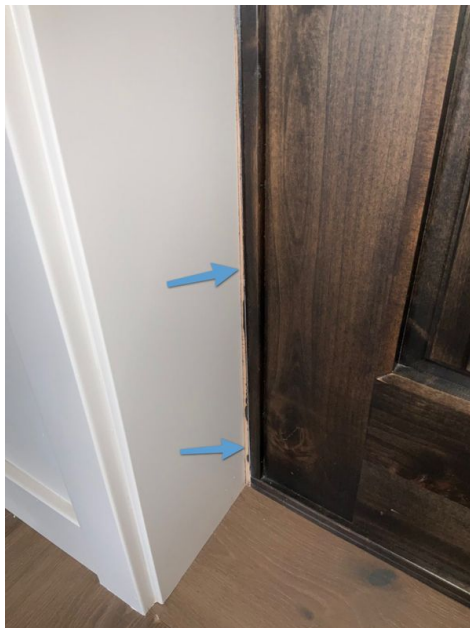
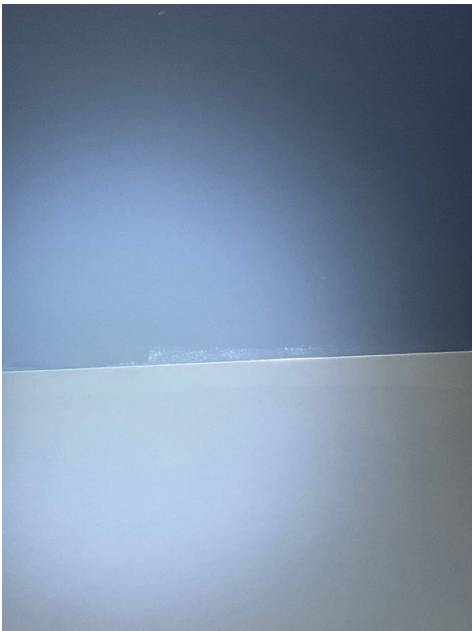
Appeared area was touched up, recommend painting to hide touch up marks.

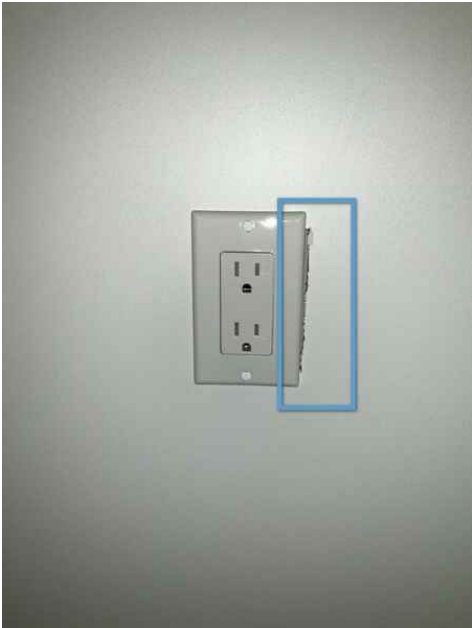
10.4.2 Floors, Walls, Ceilings
DAMAGED (GENERAL)

Outlet was in cabinet in laundry room, appears it was cut a little wide for the cover plate. Floors and walls appeared to be scratched. Recommend repair as necessary.

Recommendation
Contact your builder.

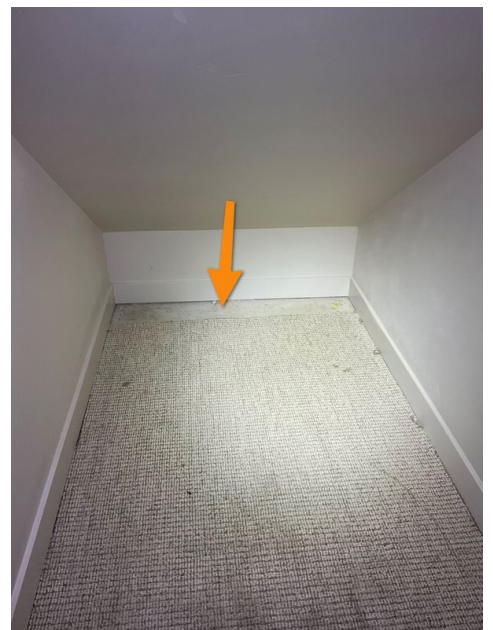
10.4.3 Floors, Walls, Ceilings

CARPET NOT FINISHED

Under steps to go upstairs, carpet was not finished to wall.
Recommend installing carpet properly.

Recommendation
Contact your builder.

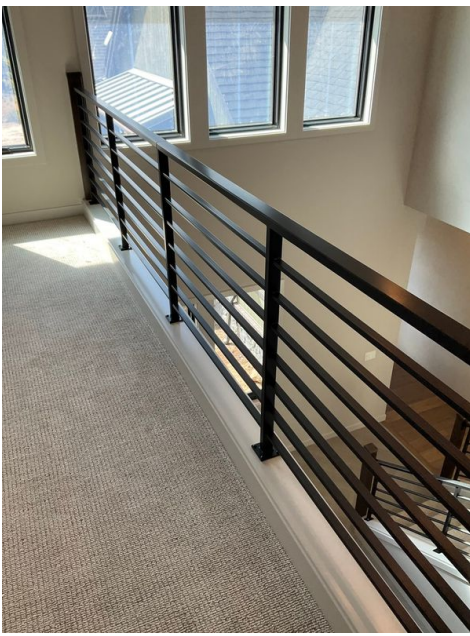
10.6.1 Railings, Guards & Handrails

HORIZONTAL CABLE

Horizontal cable railing systems have a potential to be hazardous, especially for young children who have a natural curiosity and tendency to climb things. Informational only - caution as needed.

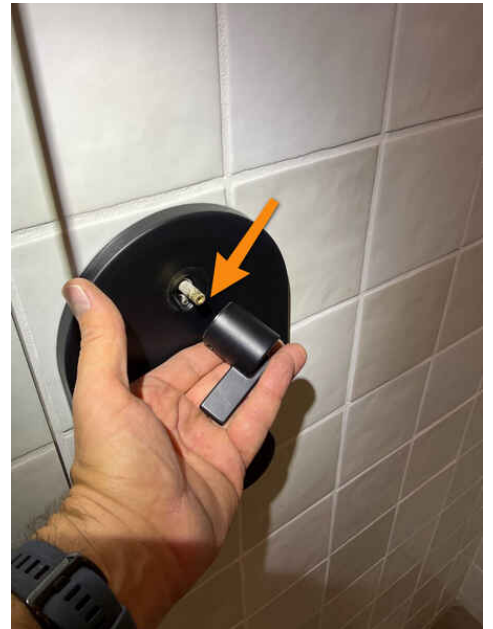
11.2.1 Sinks, Tubs & Showers

LOOSE FIXTURE

I observed indications that the fixture is loose. Recommend repair for proper operation.

Recommendation
Contact your builder.

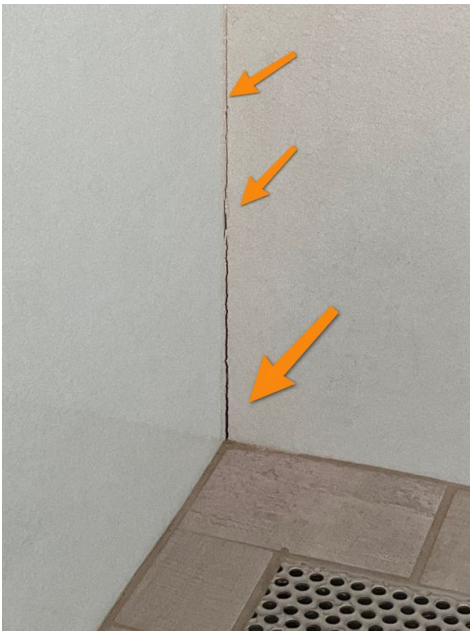
11.2.2 Sinks, Tubs & Showers

GROUT MAINTENANCE

Grout was cracked in shower area. Recommend re-grouting so water does not penetrate behind tiles.

Recommendation
Contact your builder.

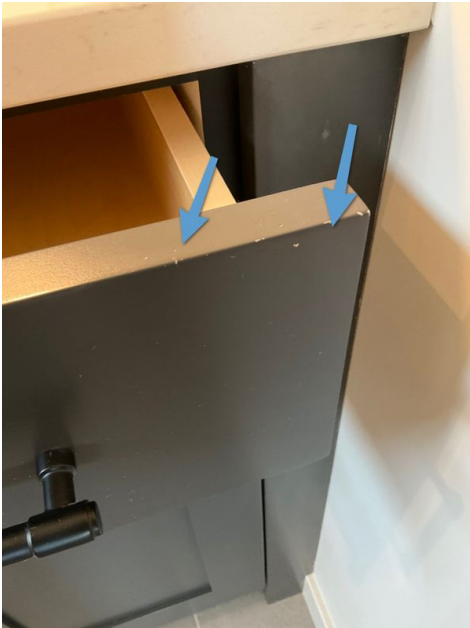
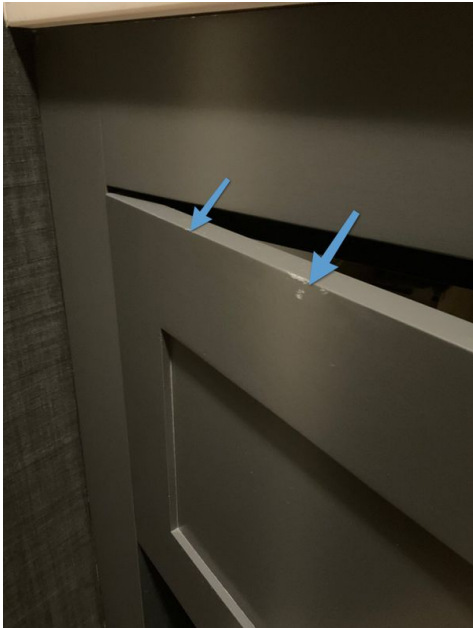
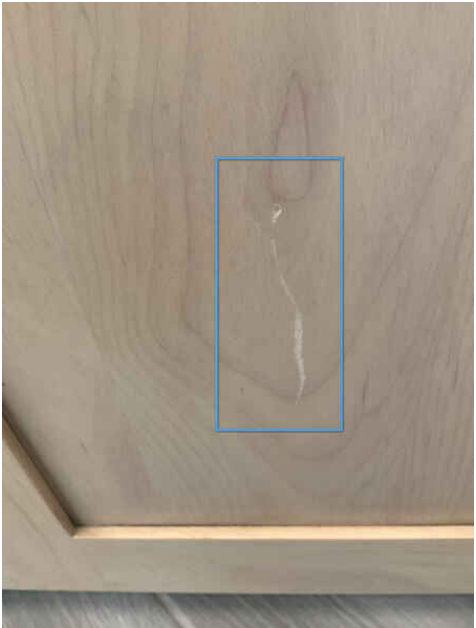
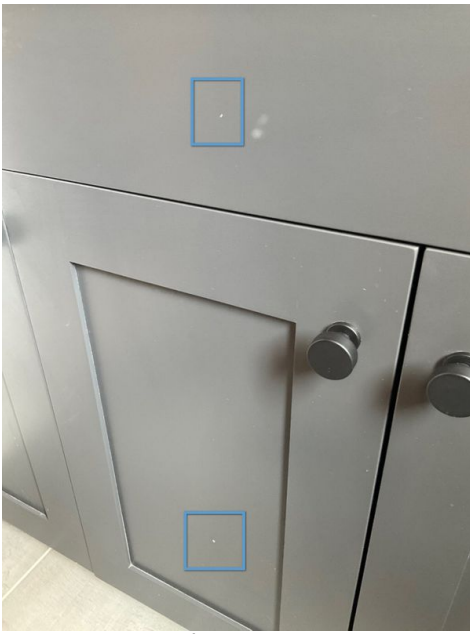
I observed indications of damage at the bathroom cabinetry. Repair as necessary.

Recommendation
Contact your builder.

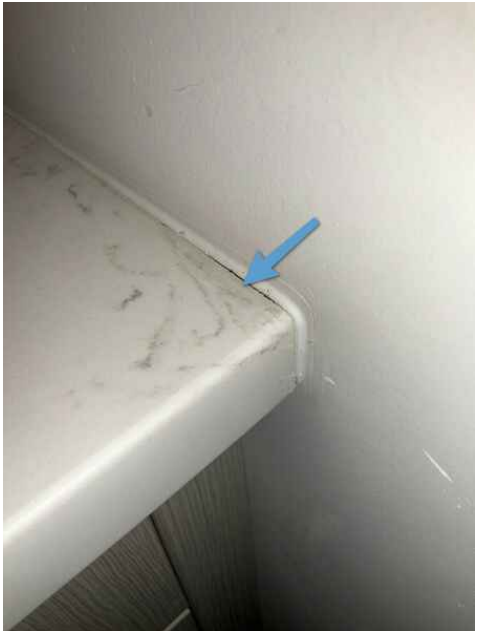
11.5.2 Cabinetry, Ceiling, Walls & Floor

GROUT MAINTENANCE

Grout had a gap to it. Recommend repair as necessary.

Recommendation
Contact your builder.

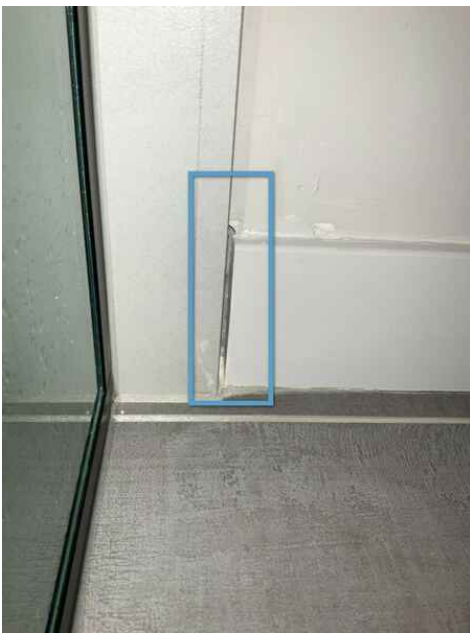
11.5.3 Cabinetry, Ceiling, Walls & Floor

GAP IN TRIM

Trim had gap in it like it was cut too short. Recommend repair as necessary.

Recommendation
Contact your builder.

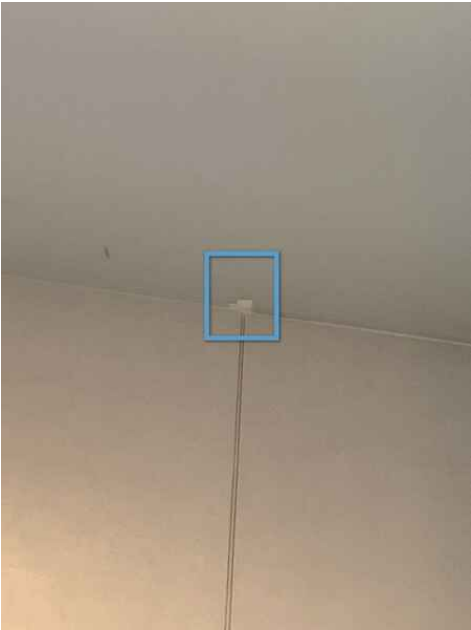
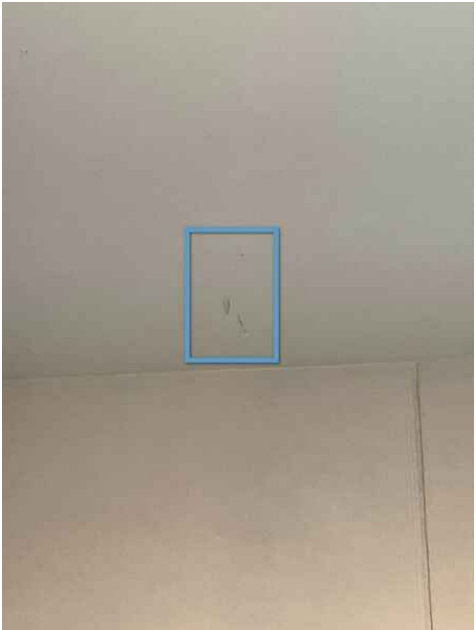
Areas needed paint maintenance.
 Recommendation
 Contact your builder.

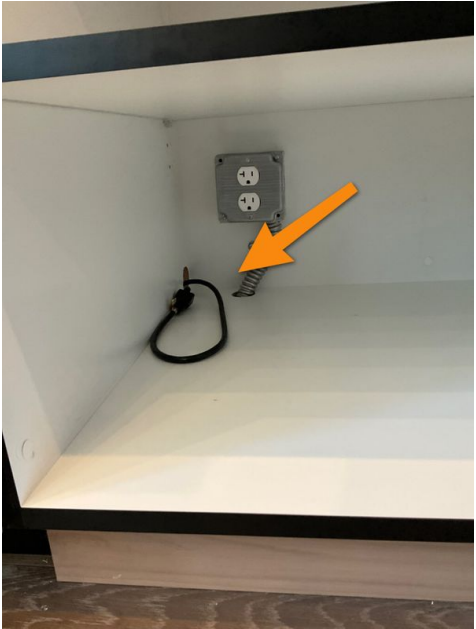
12.3.1 Dishwasher

UNPLUGGED

Dishwasher by microwave was unplugged at time of inspection. GC stated it had a bad motor, verify with builder and make sure it is operational upon move in.

Recommendation
Contact your builder.

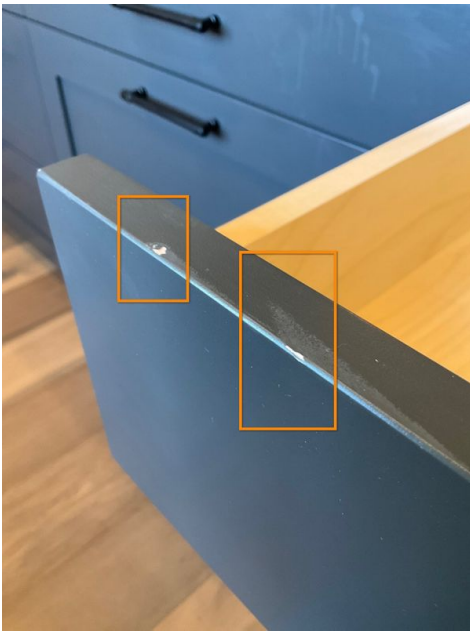
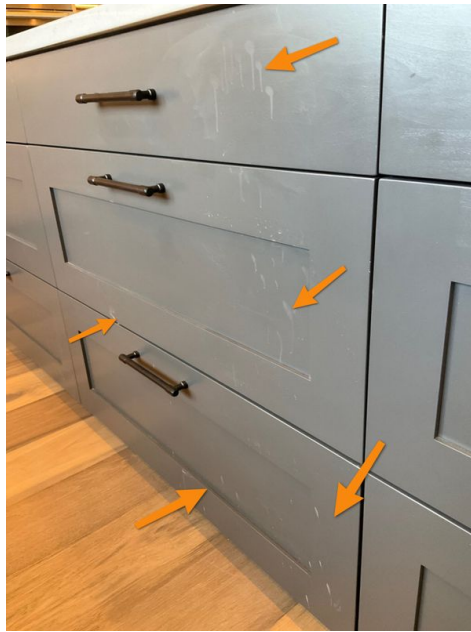
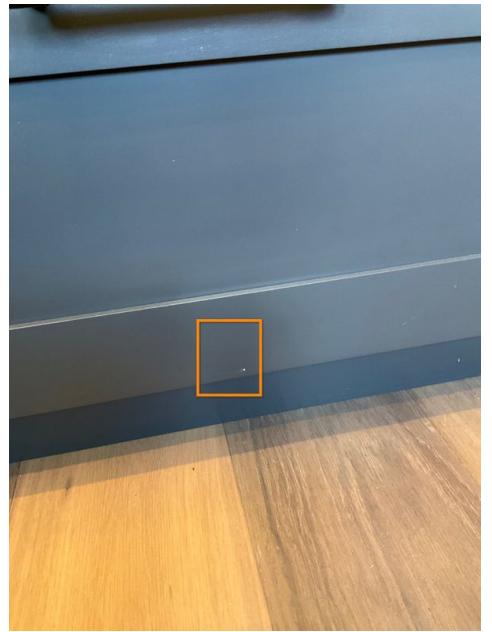
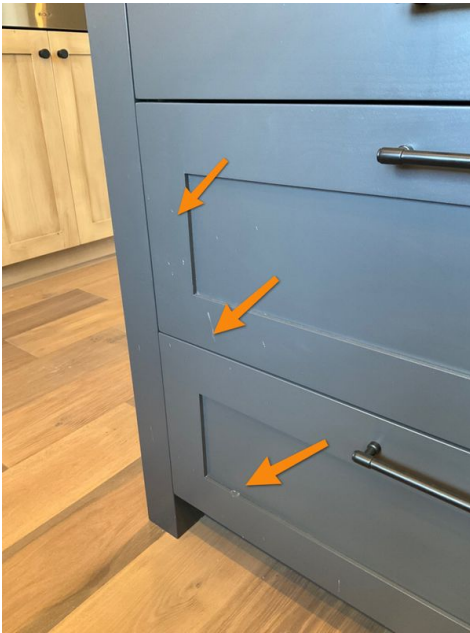
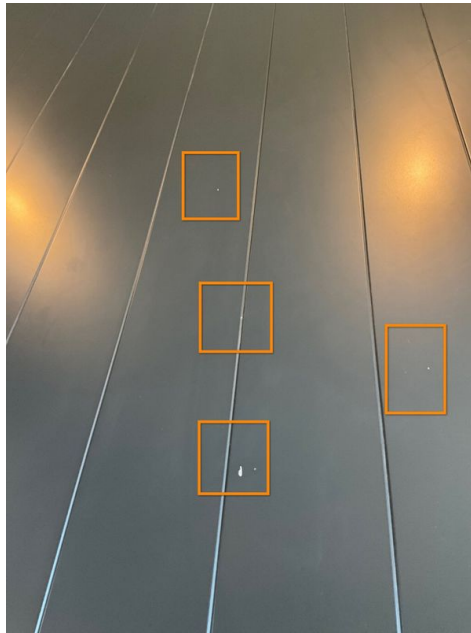
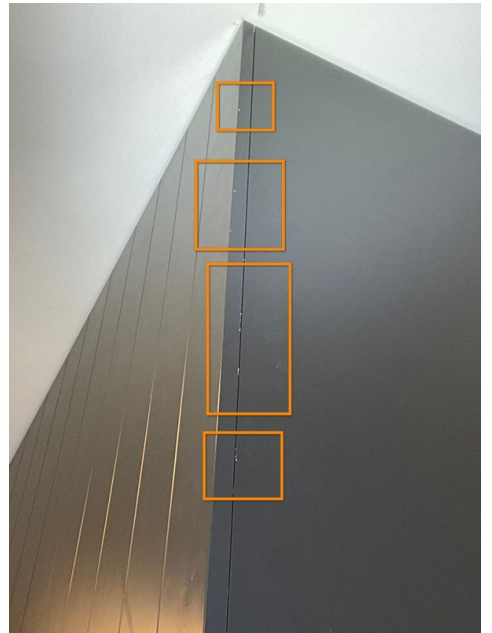
12.7.1 Countertops & Cabinets

DAMAGED CABINET

I observed damage at the kitchen cabinets. Repair as necessary.

Recommendation
Contact your builder.

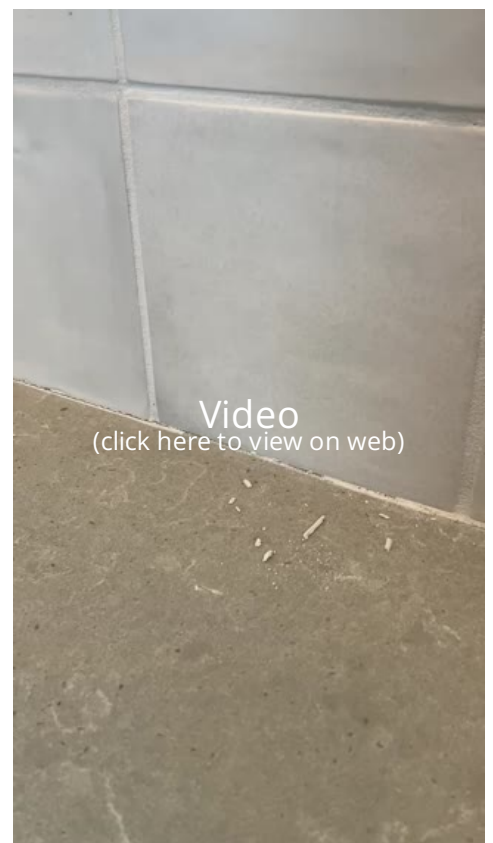
12.7.2 Countertops & Cabinets

GROUT MAINTENANCE

I observed grout needing touch up in multiple places throughout the kitchen.

Contact your builder.

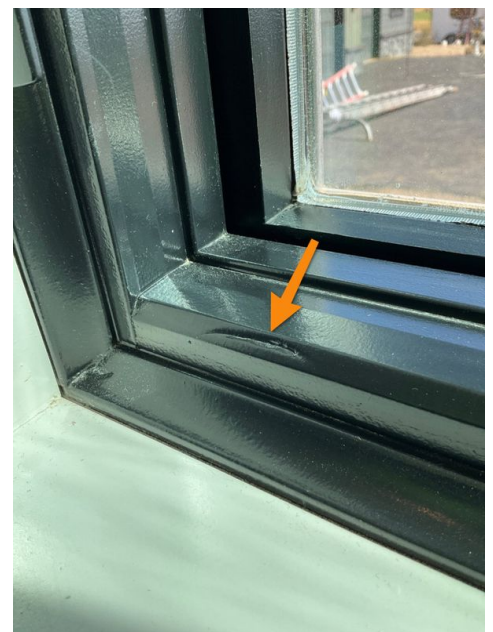
12.10.1 Windows

DAMAGED WINDOW

I observed damage to a window. Repair as necessary.

Contact your builder.

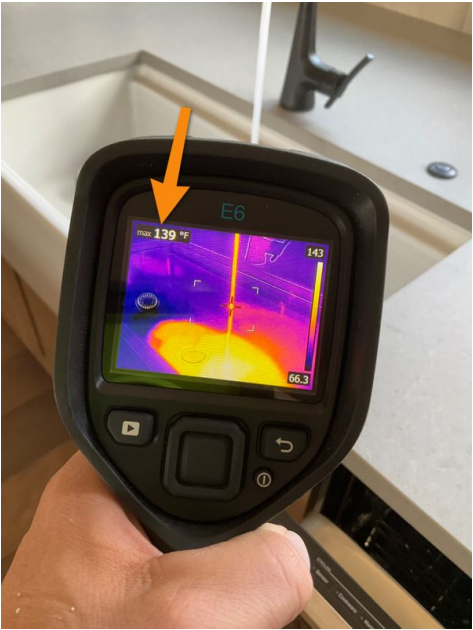
14.4.1 Hot Water Source

HOT WATER

Taken at kitchen sink. Temperatures above 120° are considered a scald hazard and consideration should be given to lowering the water heater thermostat. (More information can be obtained at <http://www.cpsc.gov/CPSCP>)

Recommendation
Contact your builder.
