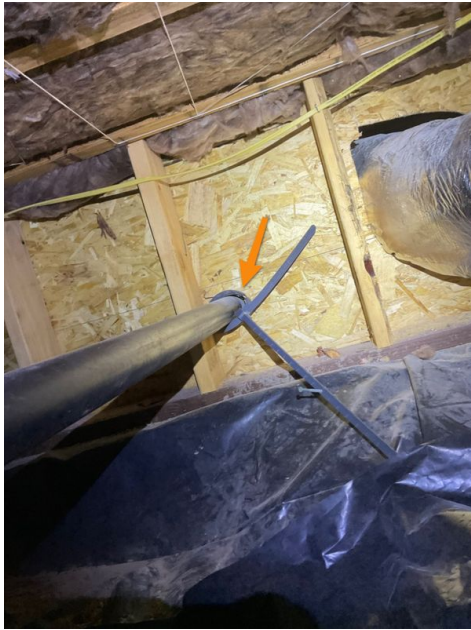
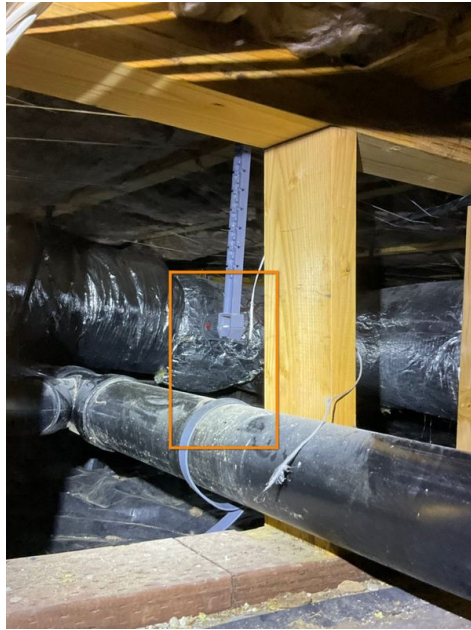
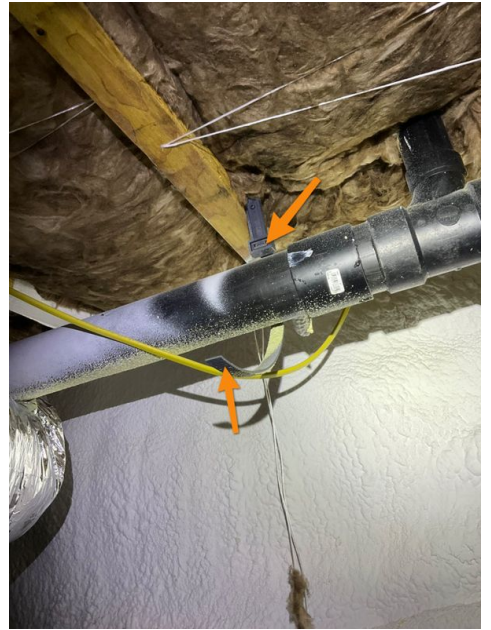
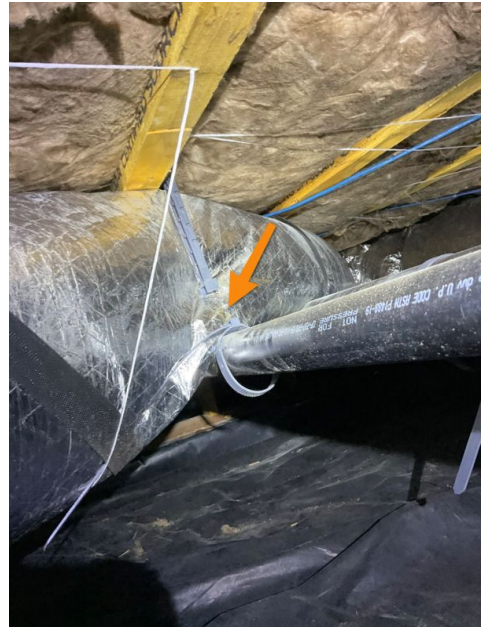
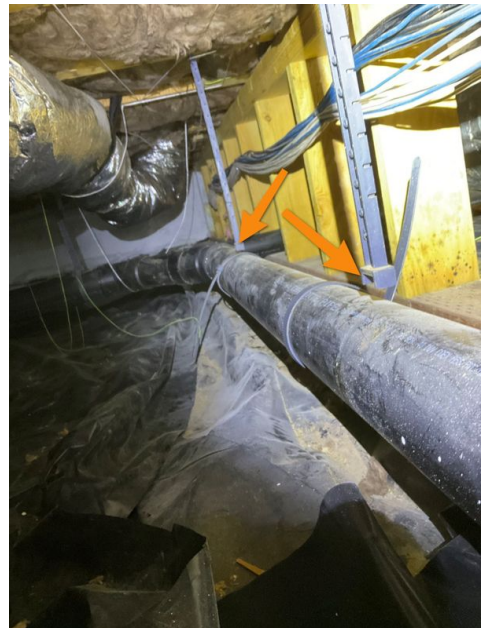
14.5.1 Drain, Waste, & Vent Systems

INADEQUATE PIPE SUPPORT

I observed sections of pipe that had broken pipe supports. Recommend proper support to facilitate water flow and not stress the plumbing.

Recommendation
Contact your builder.

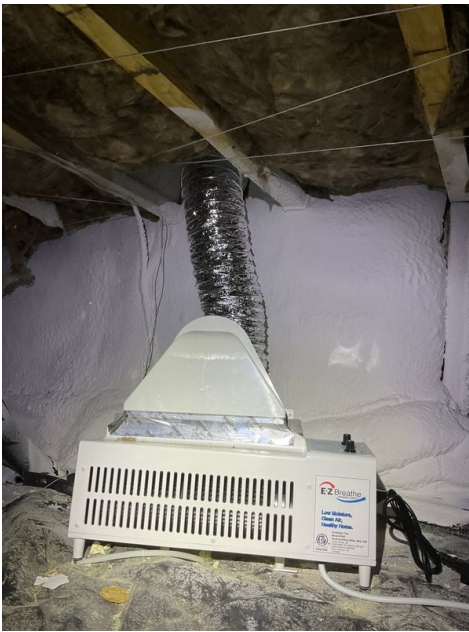
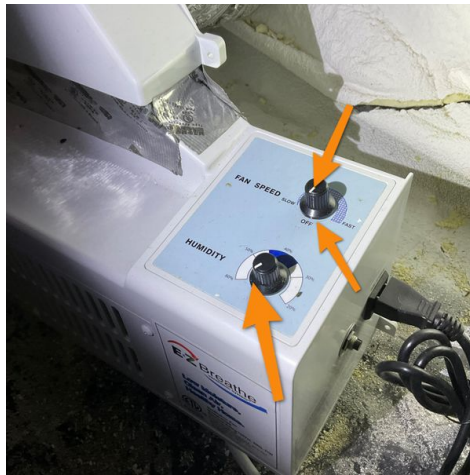
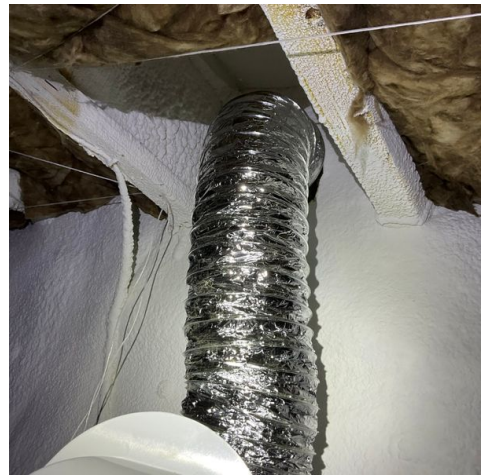
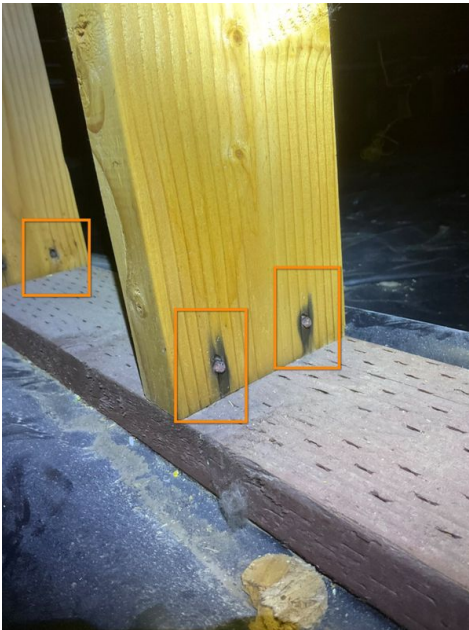
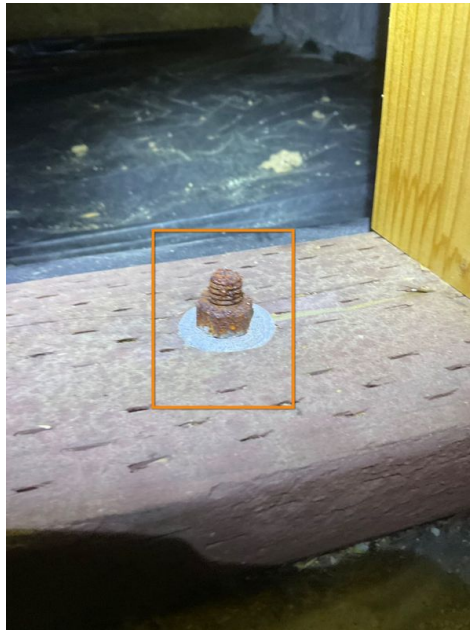
15.3.1 Ventilation In Crawlspace
EXCESSIVE HUMIDITY

I observed indications of excessive humidity levels and moisture in the crawlspace. Pictures show air exchangers and removal systems from crawl, inquire with builder as to proper settings and functionality to reduce moisture levels in crawl.

Recommendation
Contact your builder.

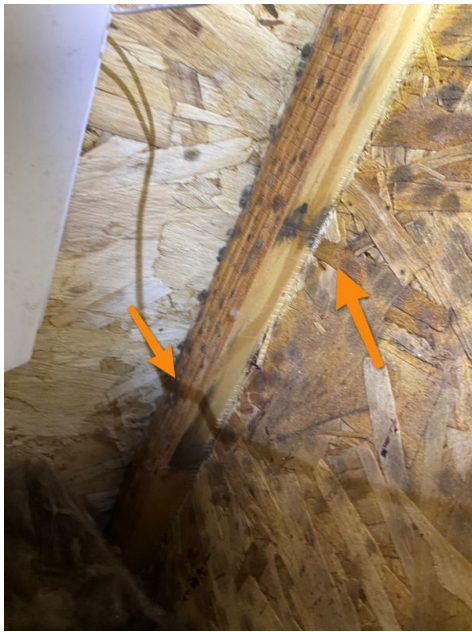
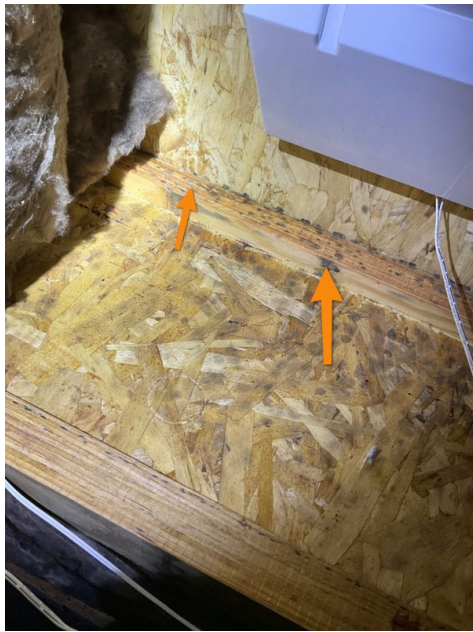
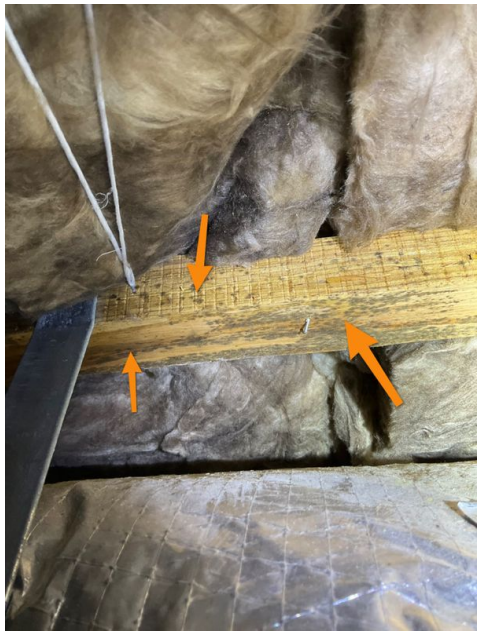
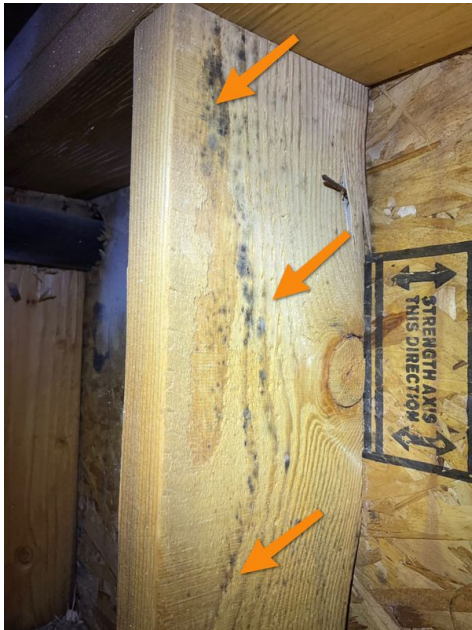
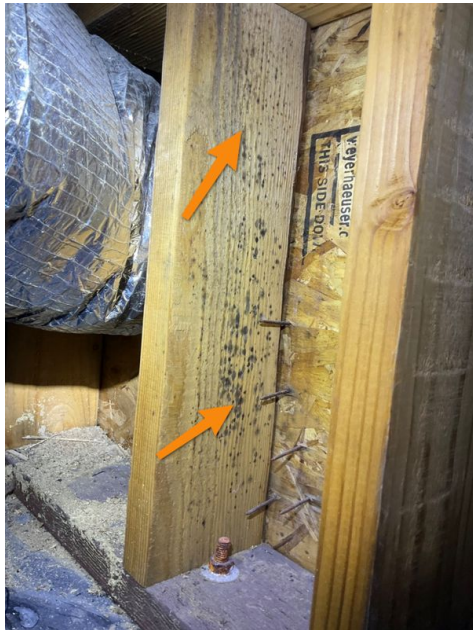
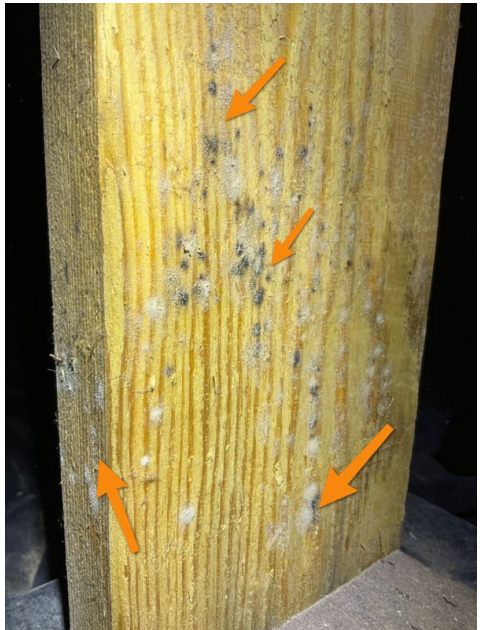
15.3.2 Ventilation In Crawlspace **POSSIBLE MICROBIAL GROWTH ISSUE**

I observed indications of a possible microbial growth on some boards. Without testing it is not determined. Recommend testing for definitive answer and remedy as necessary.

Recommendation
Contact your builder.
